HETEK

Repairs during the Construction Phase
Illustrations

Report No.99
1997

Road Directorate Denmark
Ministry of Transport

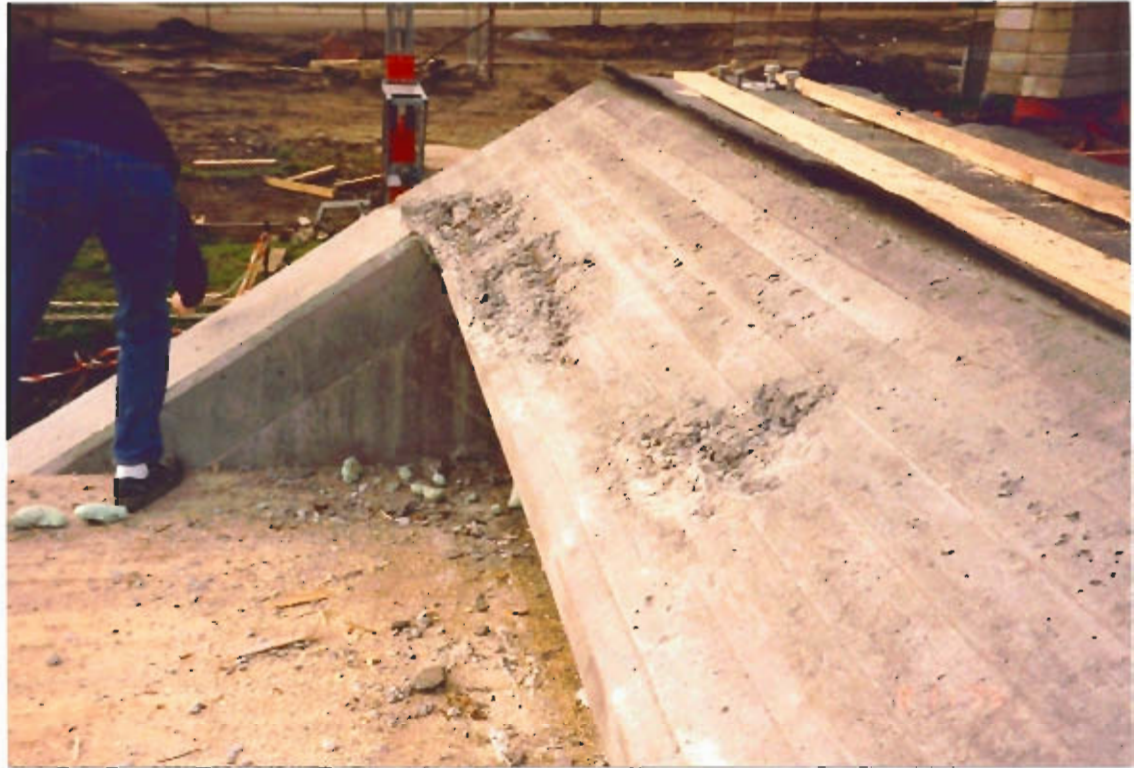
Figure 2.1

Defect: Honeycombs.

Evaluation of the defect: The honeycombs were caused by lack of compaction below the upper formwork. The defect was rather serious because reinforcement bars were exposed and the depth of the defect was considerably deeper than the concrete cover.

Repair procedure: The honeycombs were repaired by removal of the defect concrete and cleaning of the surface followed by a filling with repair mortar. In similar situations the repair could be specified according to procedures in Guidelines for Repairs during the Construction Phase see working procedures 1 and 5, alternative 1 and 7.

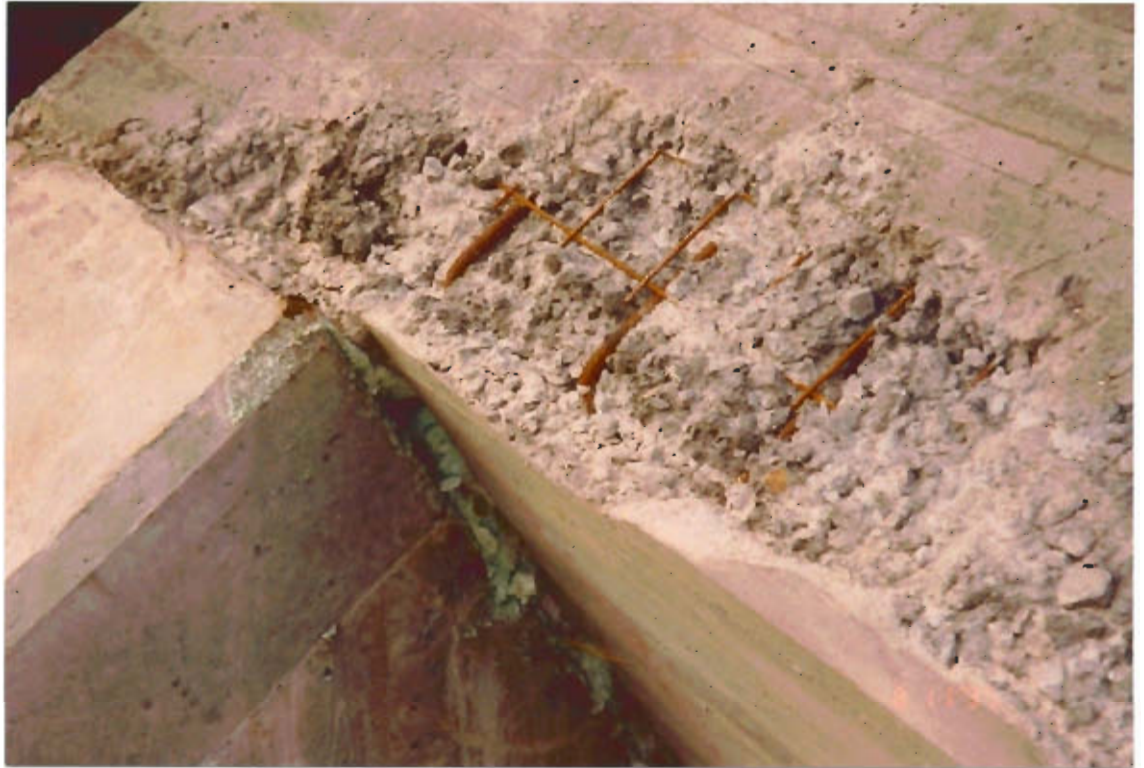
Figure 2.2

Defect: Honeycombs (same as figure 2.1).

Evaluation of the defect: The honeycombs were caused by lack of compaction below the upper formwork. The defect was serious because reinforcement bars were exposed and the depth of defect was considerably deeper than the concrete cover.

Repair procedure: The honeycombs were repaired by removal of the defect concrete and cleaning of the surface followed by a filling with repair mortar. In similar situations the repair could be specified according to procedures in Guidelines for Repairs during the Construction Phase see working procedures 1 and 5, alternative 1 and 7.

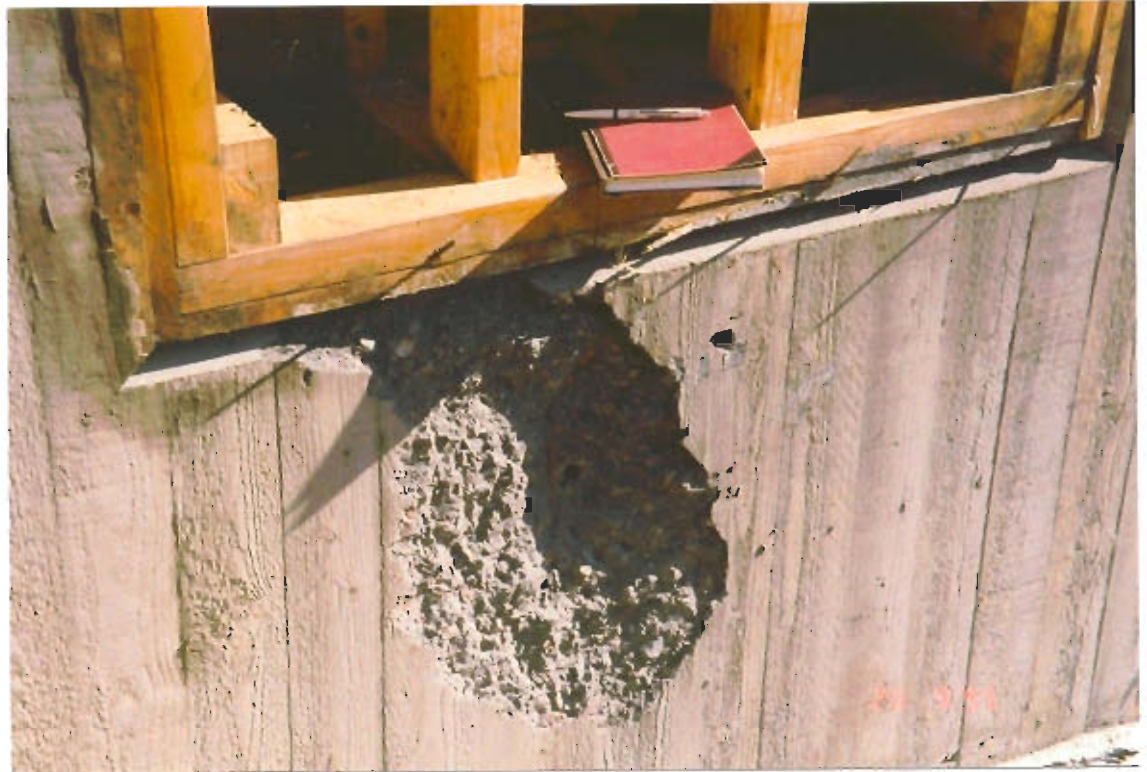
Figure 2.3

Defect: Hole.

Evaluation of the defect: Defect arisen from removal of the form. Superficial defect because the hole is small not exceeding the concrete cover.

Repair procedure: The hole was repaired by cleaning of the concrete followed by a filling with mortar. In similar situations the repair could be specified according to procedures in Guidelines for Repairs during the Construction Phase see working procedures 1 and 5.

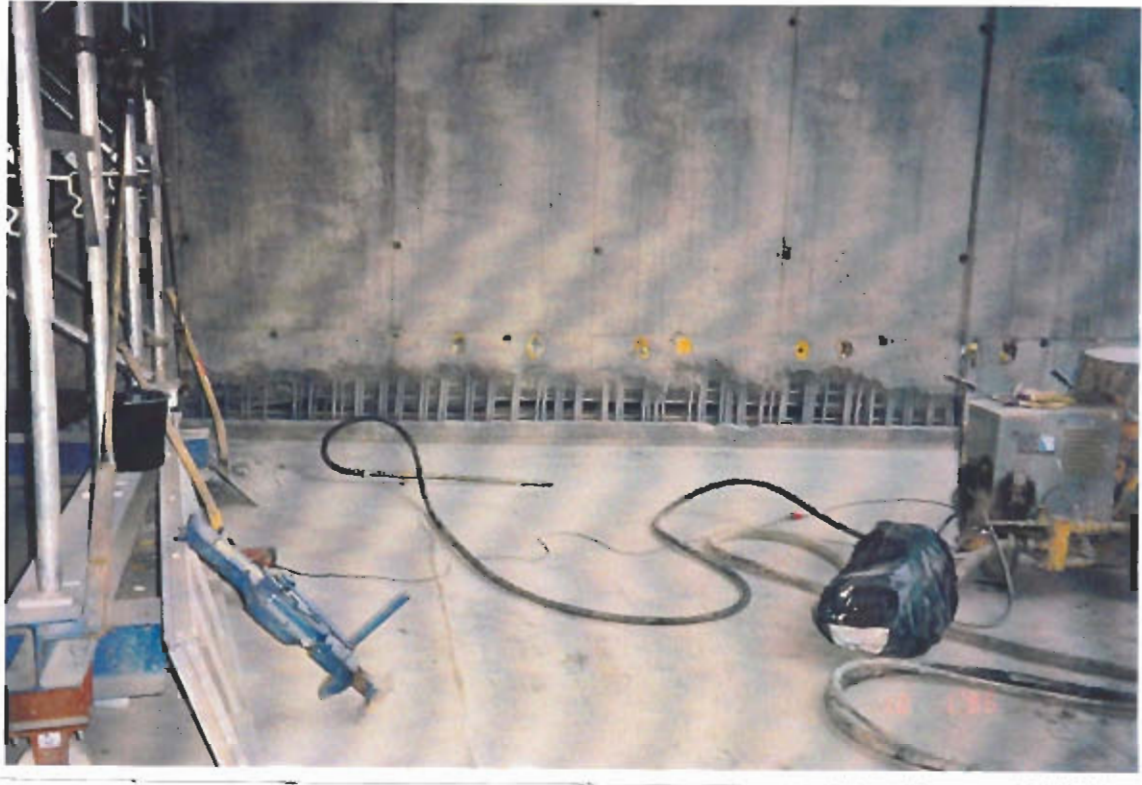
Figure 2.4

Defect: Holes.

Evaluation of the defect: The form was not cleaned properly before casting. Ice and snow was left at the bottom of the form. The defect was serious because reinforcement bars were exposed and the holes went through the construction, the defect might prevent a watertight construction.

Repair procedure: The holes were repaired by removal of the defect concrete followed by filling with concrete and the honeycombs were filled with mortar. In similar situations the repair could be specified according to procedures in Guidelines for Repairs during the Construction Phase see working procedures 1 and 5, alternative 1 and 7.

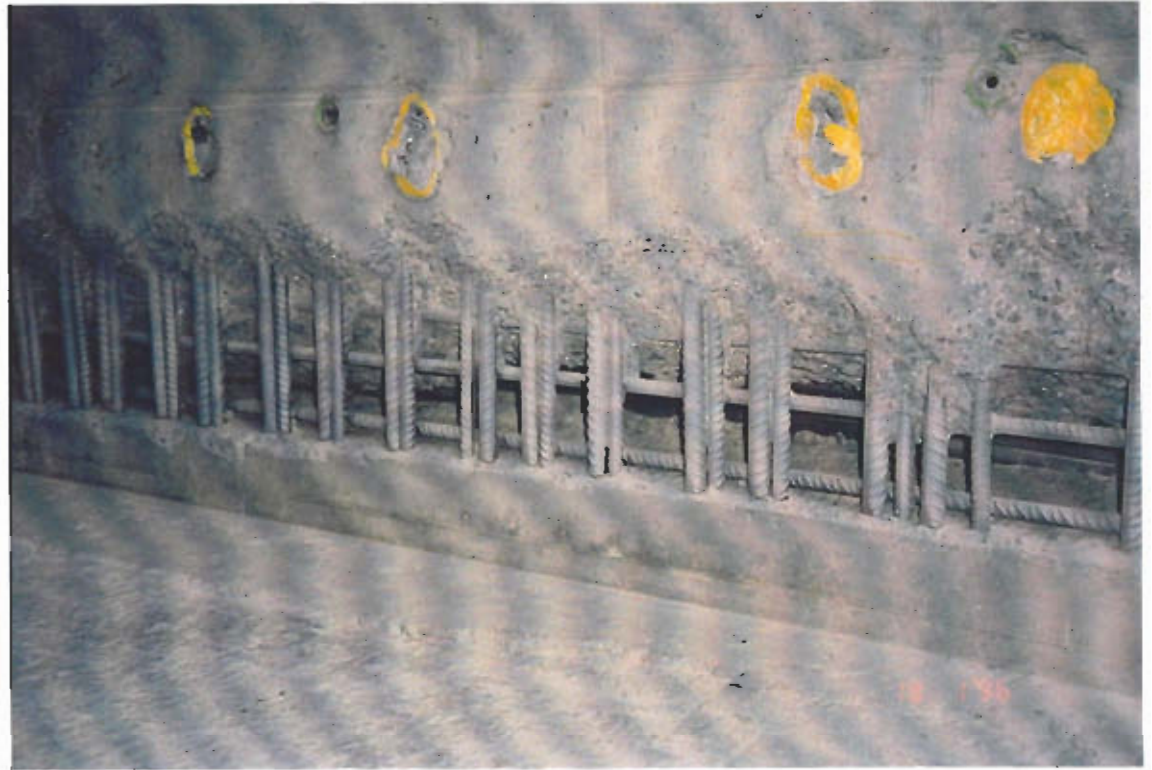
Figure 2.5

Defect: Hole - close up of figure 2.4.

Evaluation of the defect: The form was not cleaned properly before casting. Ice and snow was left at the bottom of the form. The defect was serious because reinforcement bars were exposed and the holes went through the construction, the defect might prevent a watertight construction.

Repair procedure: The holes were repaired by removal of the defect concrete and sandblasting followed by filling with concrete. In similar situations the repair could be specified according to procedures in Guidelines for Repairs during the Construction Phase see working procedures 1 and 7.

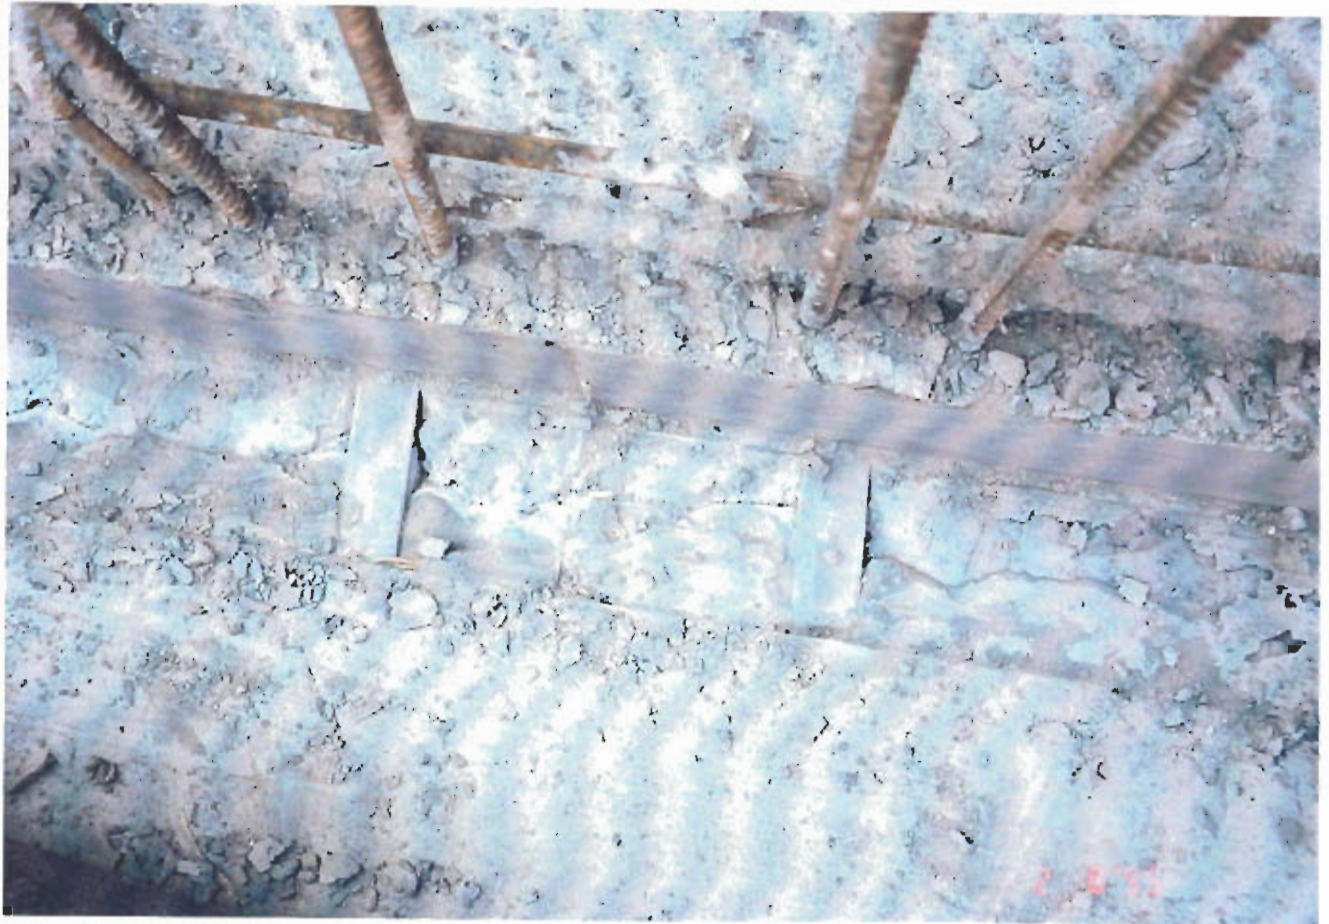
Figure 2.6

Defect: Holes and honeycombs.

Evaluation of the defect: Poorly casting/compaction of the concrete plinth. The defect was minor. The defect might prevent a watertight construction.

Repair procedure: The holes and honeycombs were repaired by cleaning of the concrete surface followed by filling with mortar. In similar situations the repair could be specified according to procedures in Guidelines for Repairs during the Construction Phase see working procedures 2 and 5.

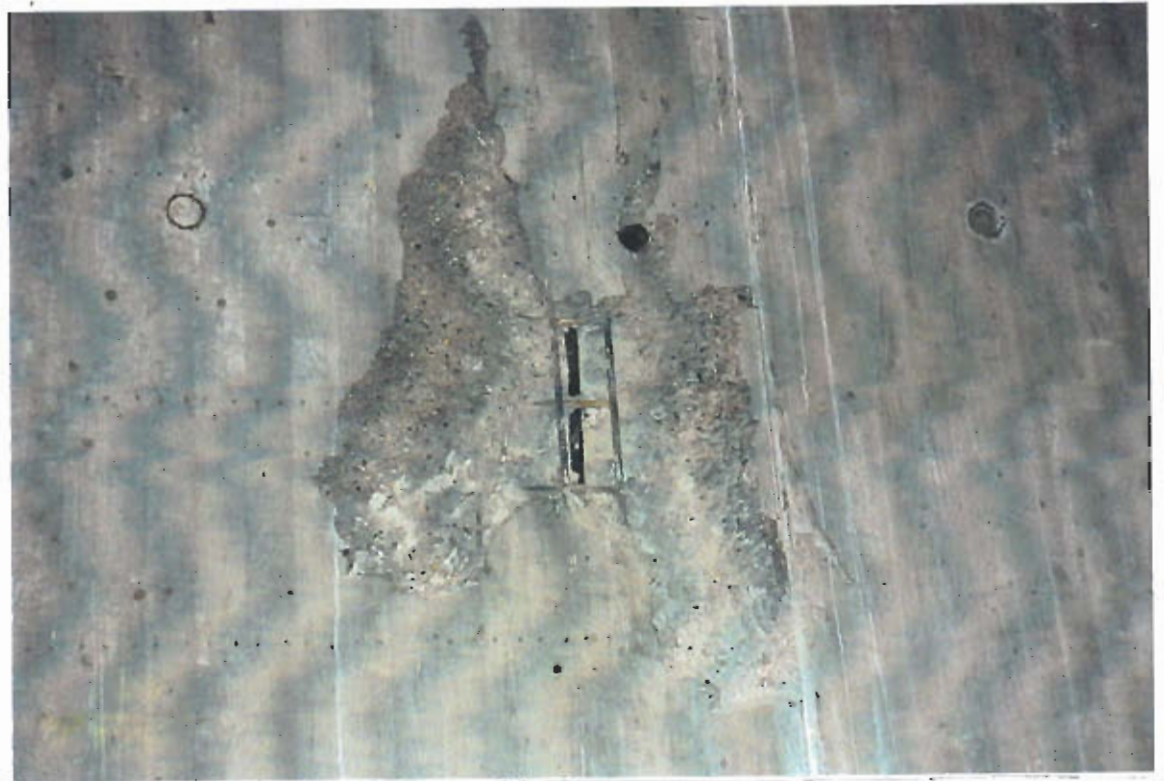
Figure 2.7

Defect: Hole after spalling of.

Evaluation of the defect: Freezing water in cooling pipe has caused the concrete cover to be pushed off and hereby expose the reinforcement bars - thus the defect was considered serious.

Repair procedure: The hole was repaired by cleaning of the concrete surface followed by filling with mortar. In similar situations the repair could be specified according to procedures in Guidelines for Repairs during the Construction Phase - see working procedures 2 and 5.

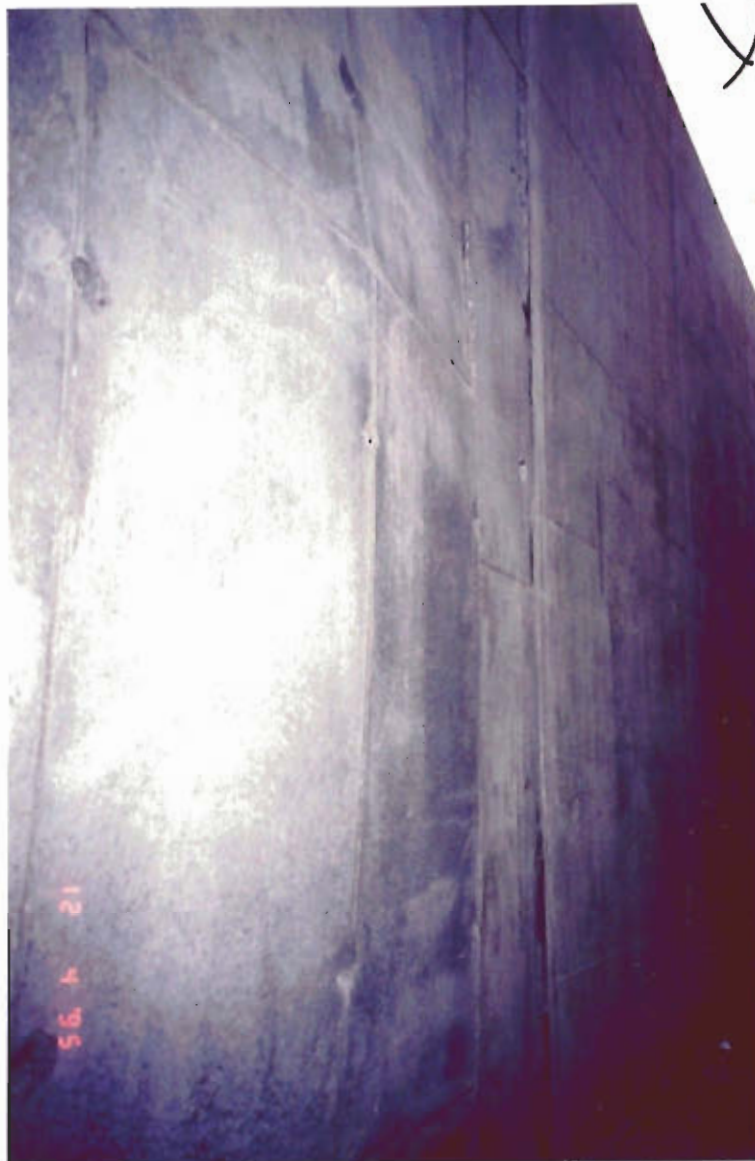
Figure 2.8

Defect: Wrong dimensions - excessive deformations of the form work.

Evaluation of the defect: The form has not been supported sufficiently during casting, resulting in a deviation in tolerances vertically and horizontally. Depending on the actual size of the deviation in tolerance, whether the reinforcement was placed in its original position, repairing of the defect might vary from none to a major removal of the wrongly placed concrete, followed by a smoothening of the surface.

Repair procedure: The concrete with wrong dimensions was repaired by removal of the concrete followed by filling with mortar. In similar situations the repair could be specified according to procedures in Guidelines for Repairs during the Construction Phase - see working procedures 1 and 5 or 6.

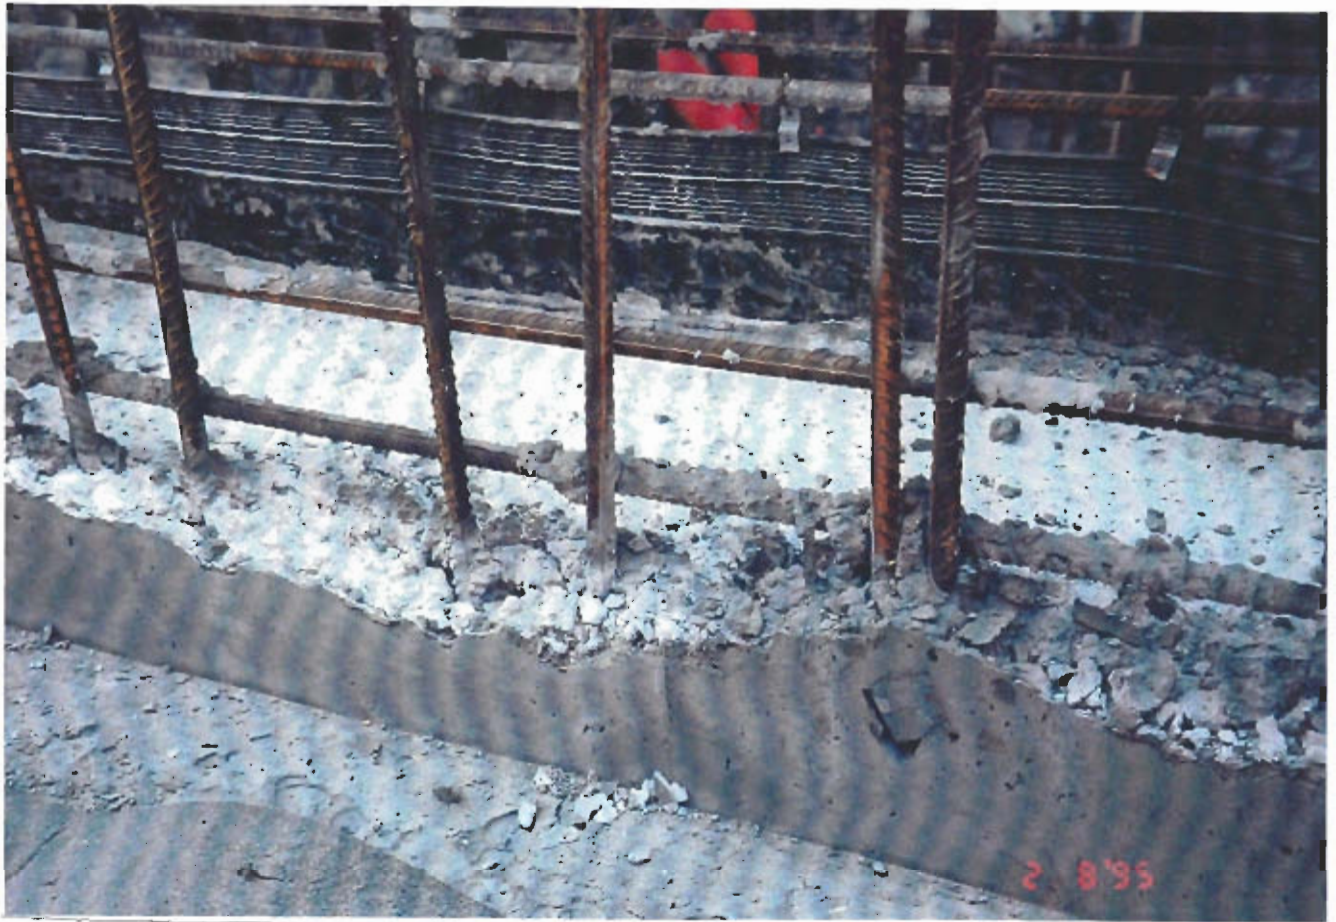
Figure 2.9

Defect: Cavities around water stops.

Evaluation of the defect: Poorly casting/compaction of the concrete plinth. The defect was of serious nature because half of the water stop was not cast in as supposed. The defect might prevent a watertight construction.

Repair procedure: The holes were repaired by cleaning of the concrete surface followed by filling with mortar. Similar situations are partly covered by the Guidelines for Repairs during the Construction Phase - working procedure 2 and 5 but a special repair procedure should be prepared including e.g. the use of injection tubes in the defect casting joint.

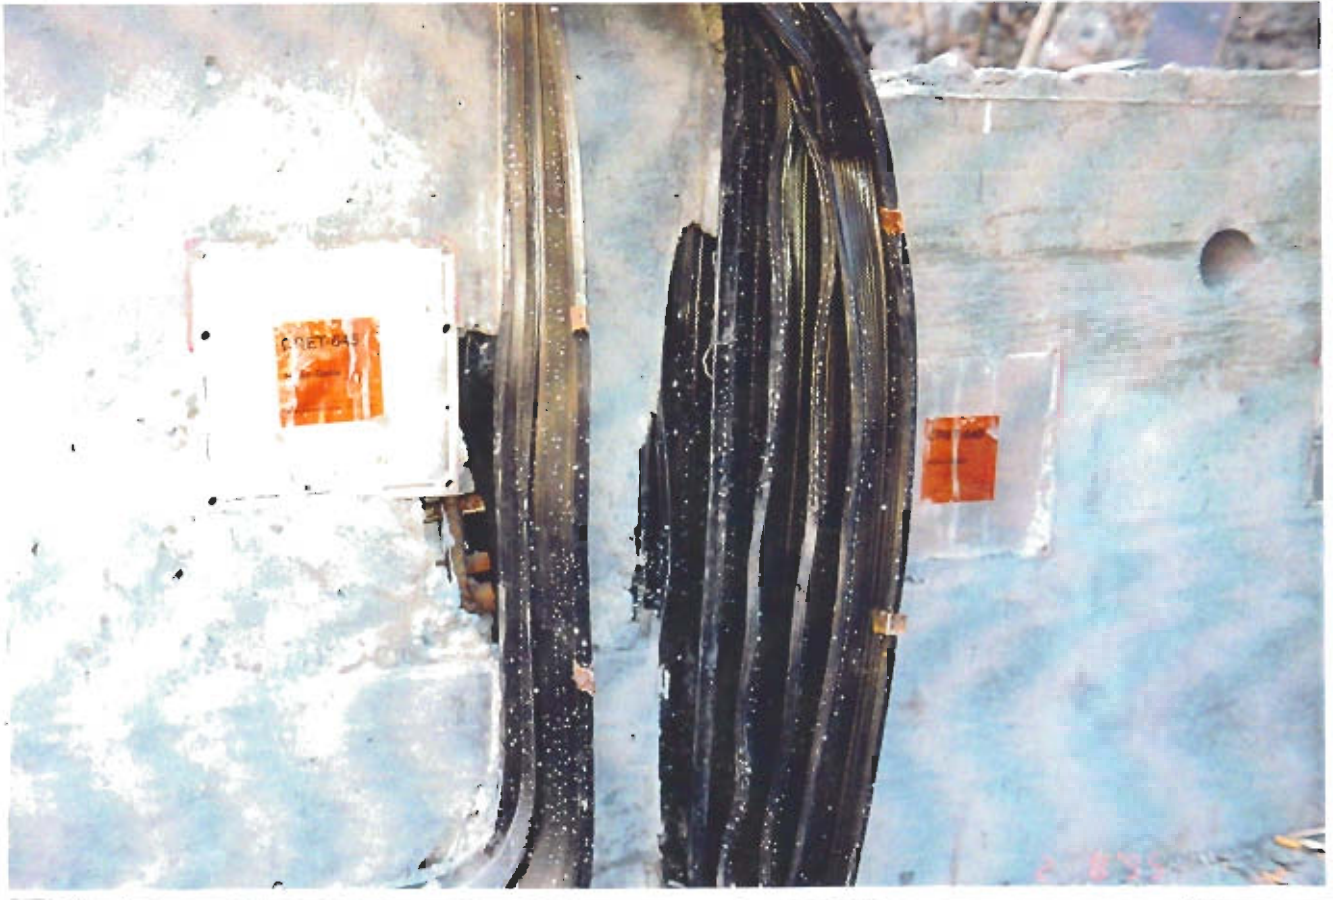
Figure 2.10

Defect: Cavities around water stops.

Evaluation of the defect: Poorly casting/compaction of the concrete at bottom of a tunnelslab around water stop and the mandrel. The defect was of serious nature because half of the water stop was not cast in as supposed. The defect might prevent a watertight construction. The mechanical function of the mandrel is reduced.

Repair procedure: The holes were repaired by cleaning of the concrete surface followed by filling with mortar. Similar situations are partly covered by the Guidelines for Repairs during the Construction Phase - see working procedures 2 and 5 but special repair procedures should be prepared including e.g. the use of injection tubes in the defect casting joint.

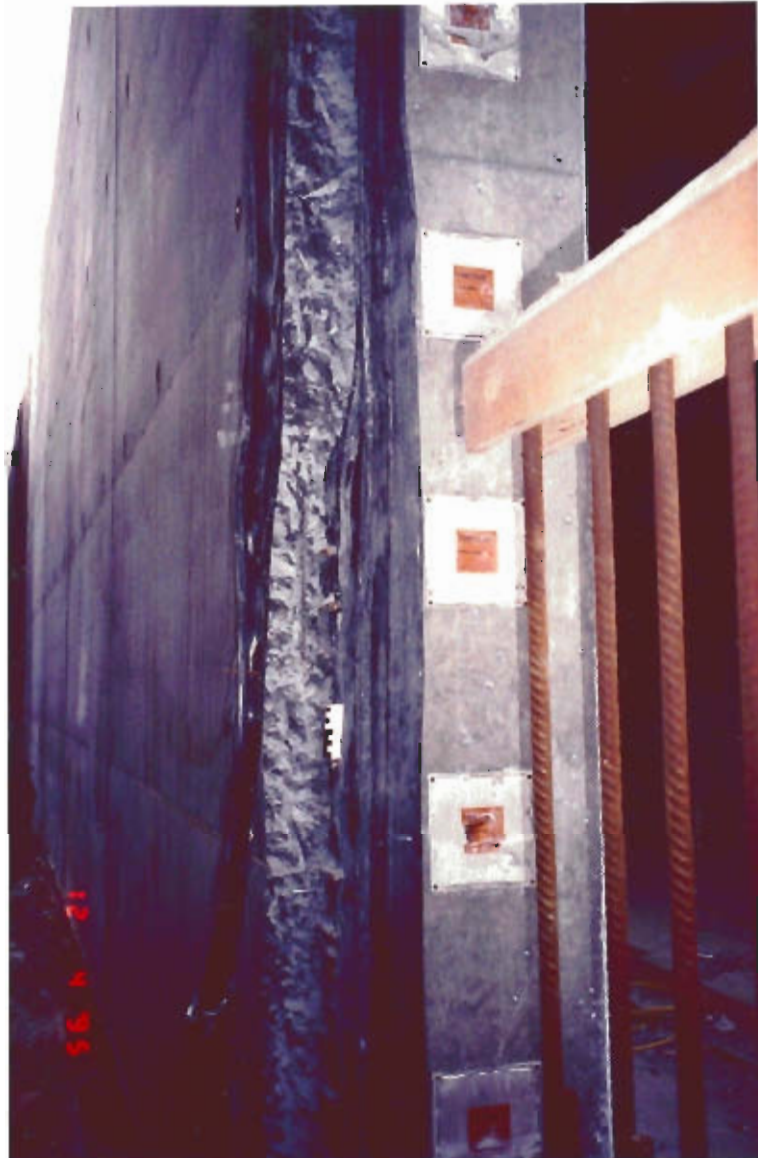
Figure 2.11

Defect: Cavities around water stops.

Evaluation of the defect: Poorly workmanship in placing the water stop. The defect was of serious nature because half of the water stop was not cast in as supposed and the defect might prevent a watertight construction.

Repair procedure: Special repair procedures should be prepared including consideration of e.g. the use of injection tubes in the defect casting joint.

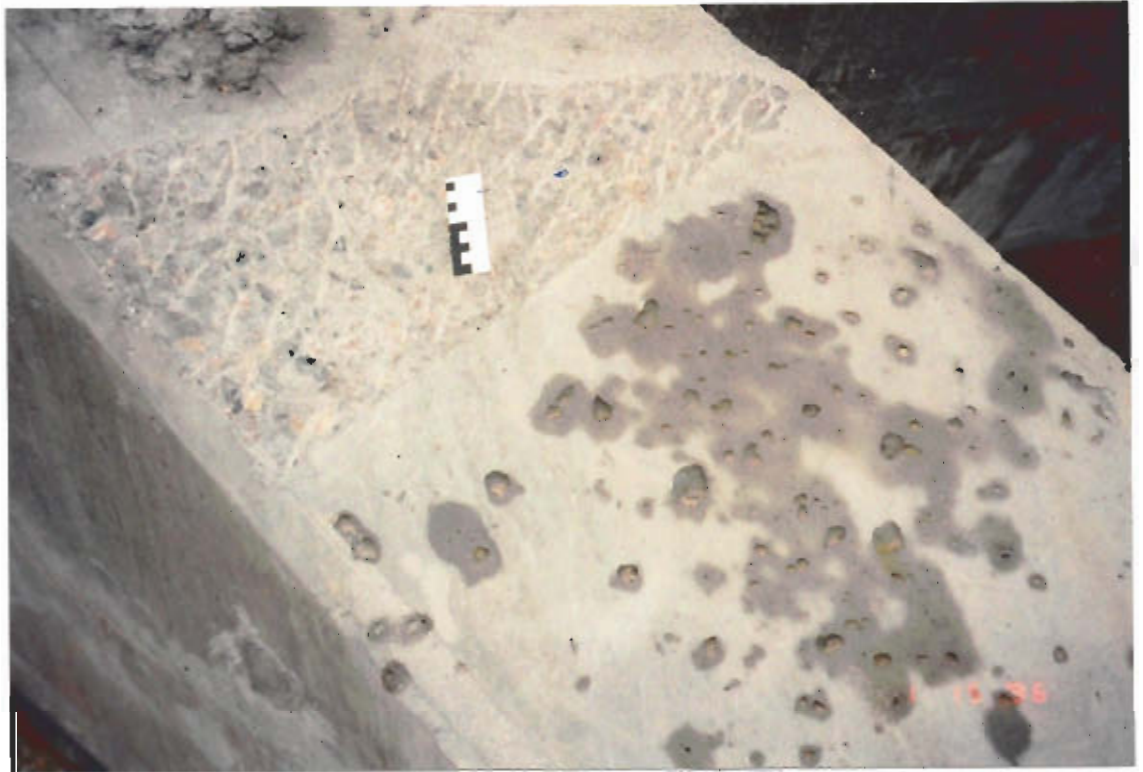
Figure 2.12

Defect: Air voids.

Evaluation of the defect: Lack of compaction. The defects was considered as a superficial defect with only aesthetic consequences.

Repair procedure: The air voids were repaired by cleaning of the concrete surface followed by filling with mortar. Similar situations are specified in the Guidelines for Repairs during the Construction Phase - see working procedures 2 and 5.

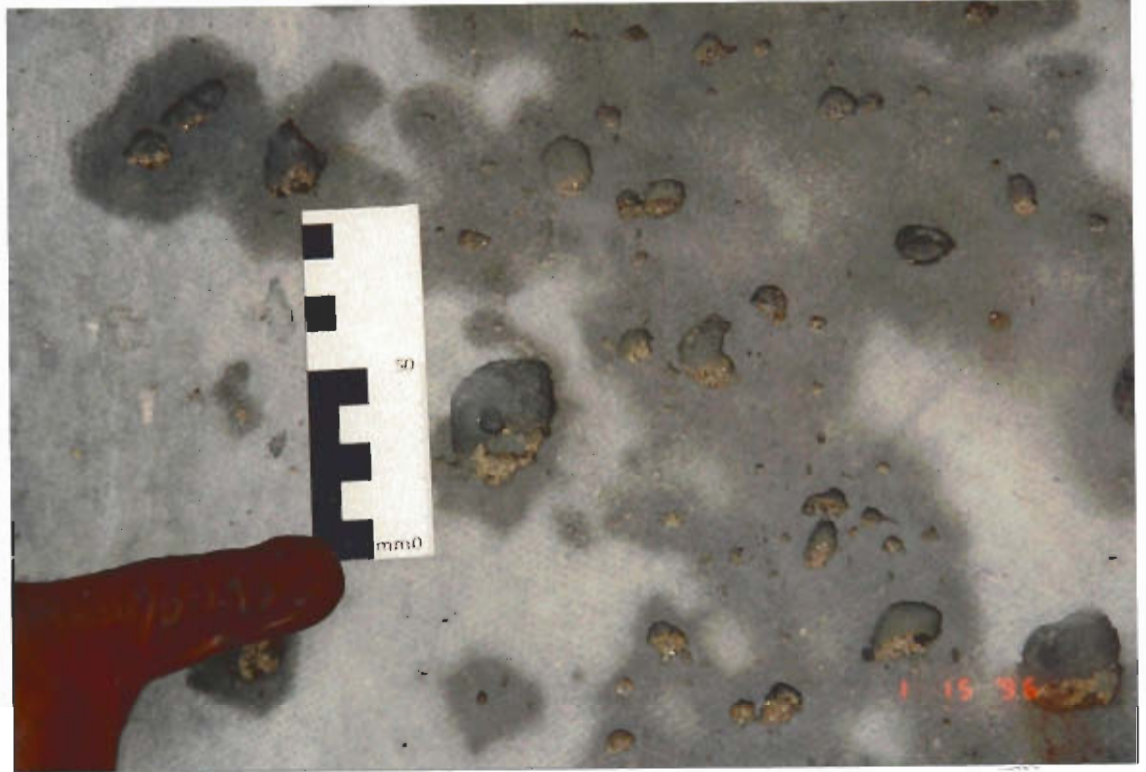
Figure 2.13

Defect: Air voids - close up of figure 2.12.

Evaluation of the defect: Lack of compaction. The defect was considered a superficial defect with only aesthetic consequence.

Repair procedure: The air voids were repaired by cleaning of the concrete surface followed by filling with mortar. Similar situations are specified in the Guidelines for Repairs during the Construction Phase - see working procedures 2 and 5.

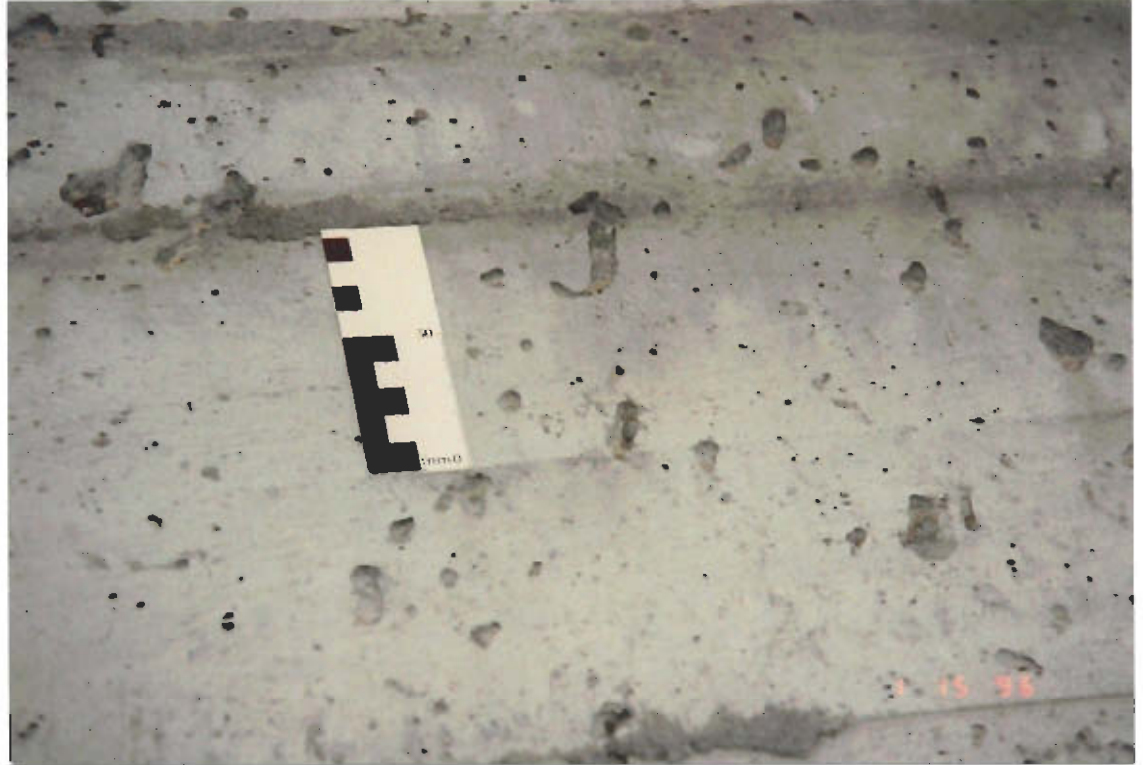
Figure 2.14

Defect: Air voids.

Evaluation of the defect: Lack of compaction. The defect was considered a superficial defect with aesthetic consequence.

Repair procedure: The air voids were repaired by cleaning of the concrete surface followed by filling with mortar. Similar situations are specified in the Guidelines for Repairs during the Construction Phase - see working procedures 2 and 5.

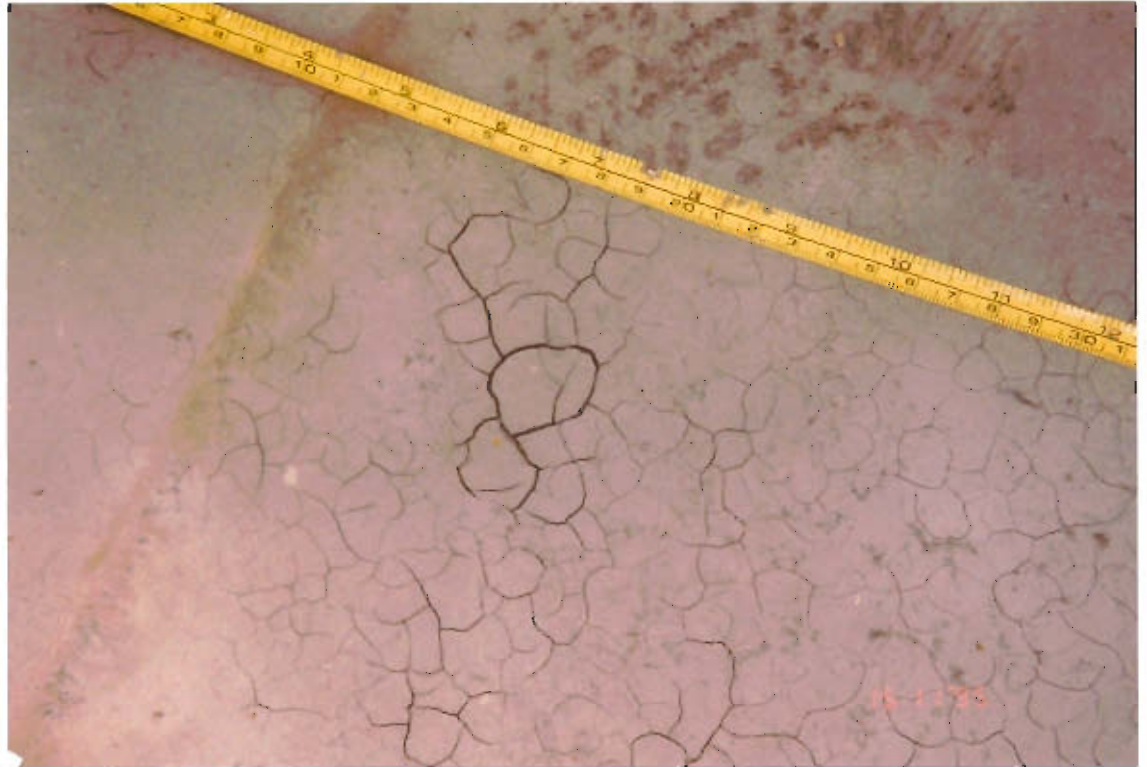
Figure 2.15

Defect: Cracks. Drying cracks in the surface of the concrete.

Evaluation of the defect: The concrete deck surface was exposed to very heavy rain during the casting, and the picture shows the dried wash-out surface of the top of the concrete surface. The defect was of minor importance for the durability of the construction as it was only in the top of the concrete cover.

Repair Procedure: The defect concrete was washed away by high water jet before a membrane was applied. Similar situations are partly covered by the Guidelines for Repairs during the Construction Phase - see working procedures 1 and 5, alternative 1 and 7.

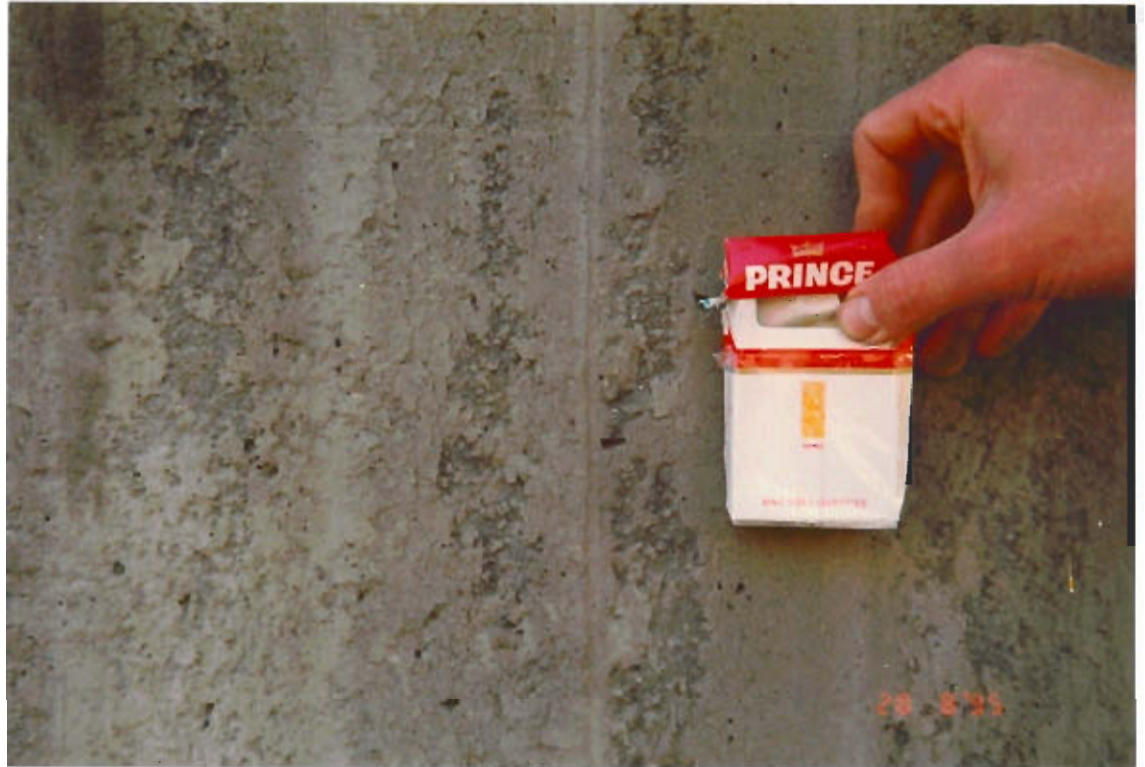
Figure 2.16

Defect: Minor surface defects.

Evaluation of the defect: The surface was damaged because of insufficient formwork without enough formoil. The defects were considered superficial defect with only aesthetic consequence.

Repair procedure: The surface was not repaired and should only be repaired if there is a special need.

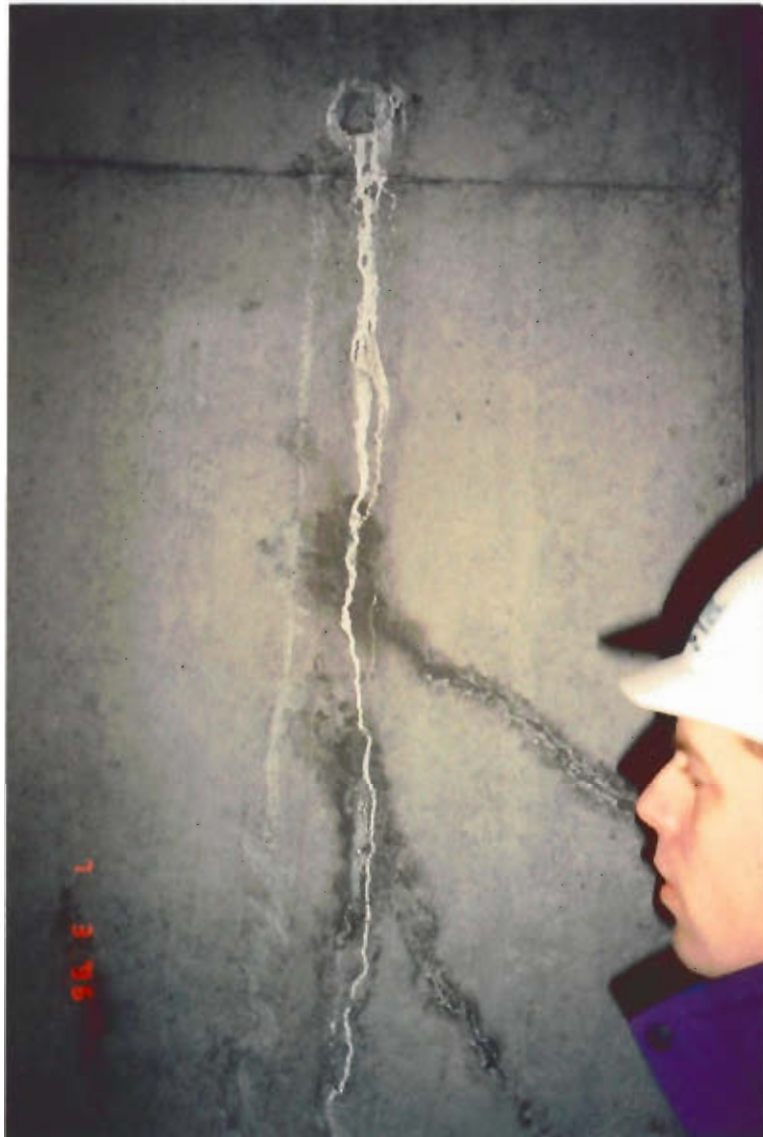
Figure 2.17

Defect: Leaking clamp holes and cracks.

Evaluation of the defect: Leaking water from filled in clamp holes and cracks.

Repair procedure: The clam holes and cracks were injected with polyurethane. Similar situations are partly covered by the Guidelines for Repairs during the Construction Phase - see working procedures 4 and 8.

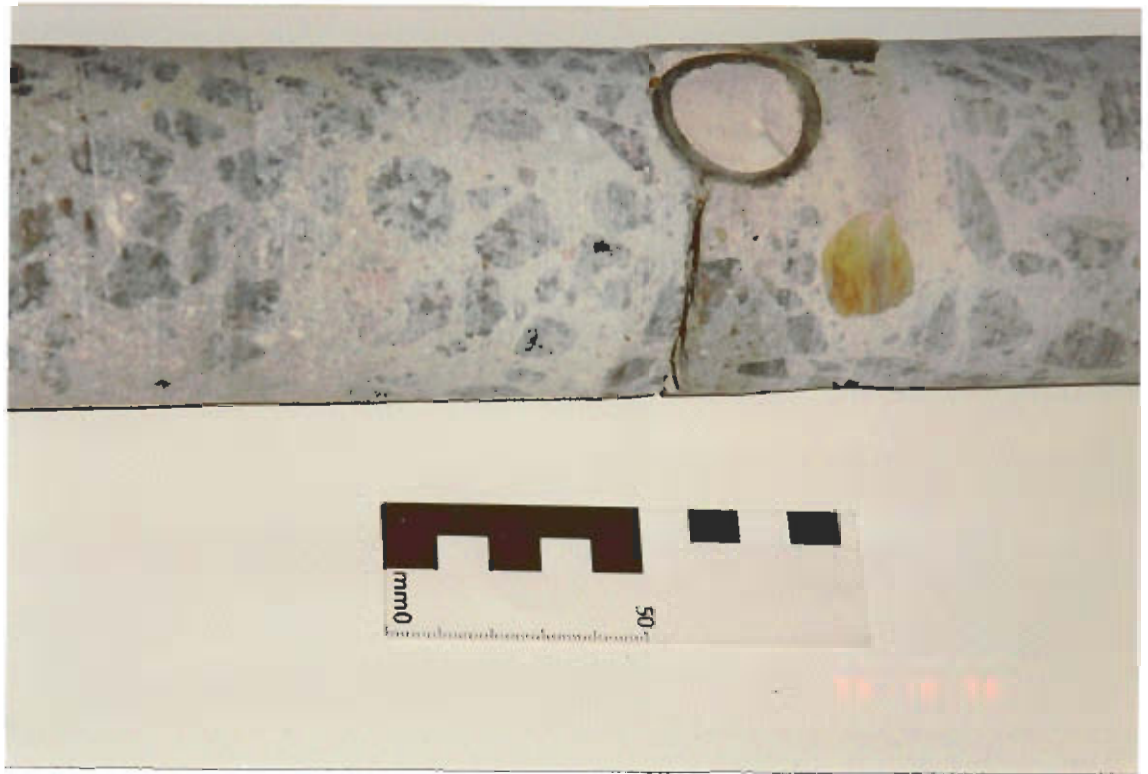
Figure 2.18

Defect: Cracks across an injected cooling pipe of plastic.

Evaluation of the defect: Cooling pipes of plastic may be channels which can lead water through a wall, thus resulting in numerous leaking cracks and holes.

Repair procedure: The cracks were injected with polyurethane. Similar situations are partly covered by the Guidelines for Repairs during the Construction Phase - see working procedures 4 and 8. Thus special considerations should be made before choosing the cooling pipes and placing them in the form.

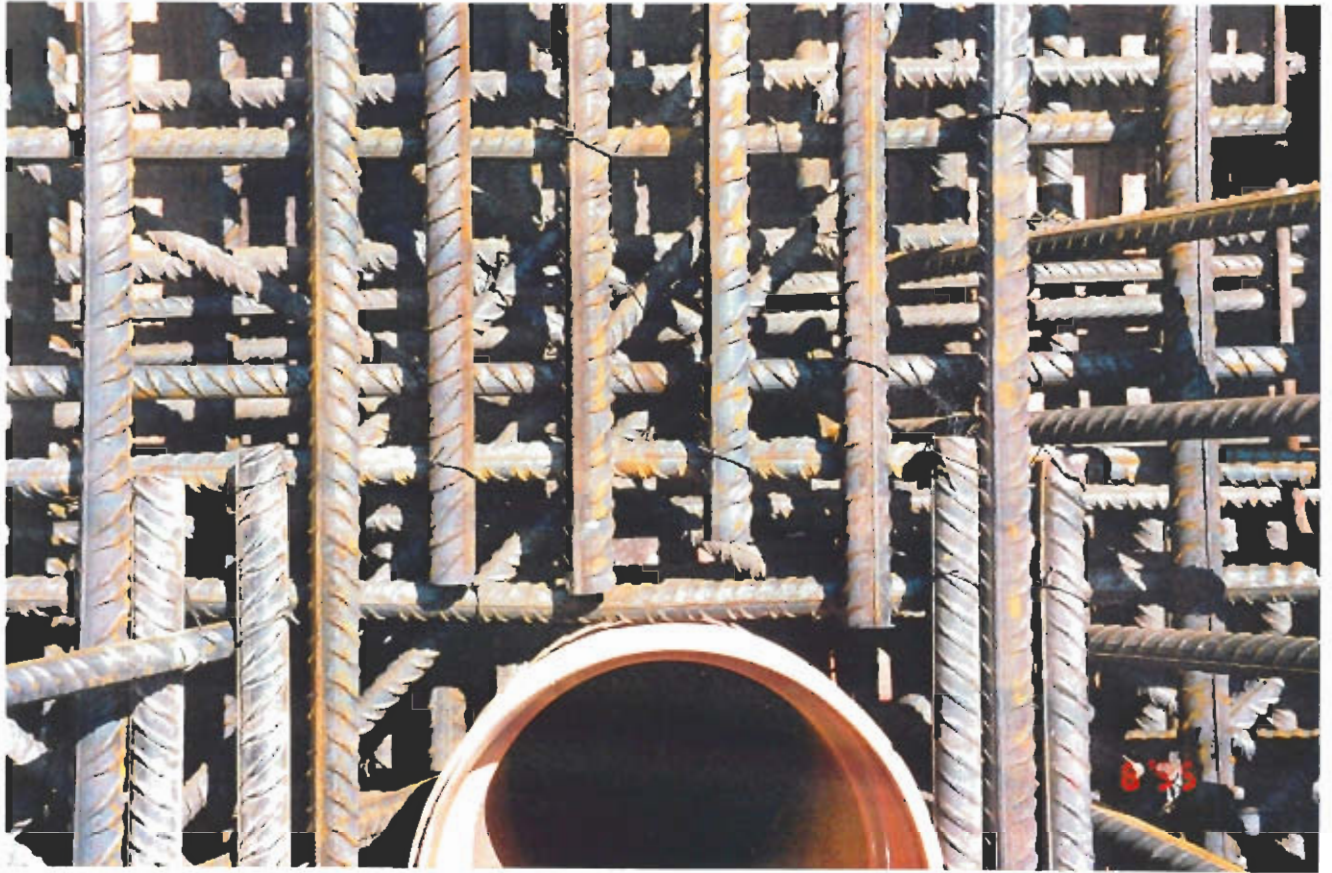
Figure 2.19

Impractical arrangement of reinforcement surrounding a drainpipe in a slab. The reinforcement does not leave much space for casting and compaction equipment and there is a great risk of holes and honeycombs in this part of the construction.

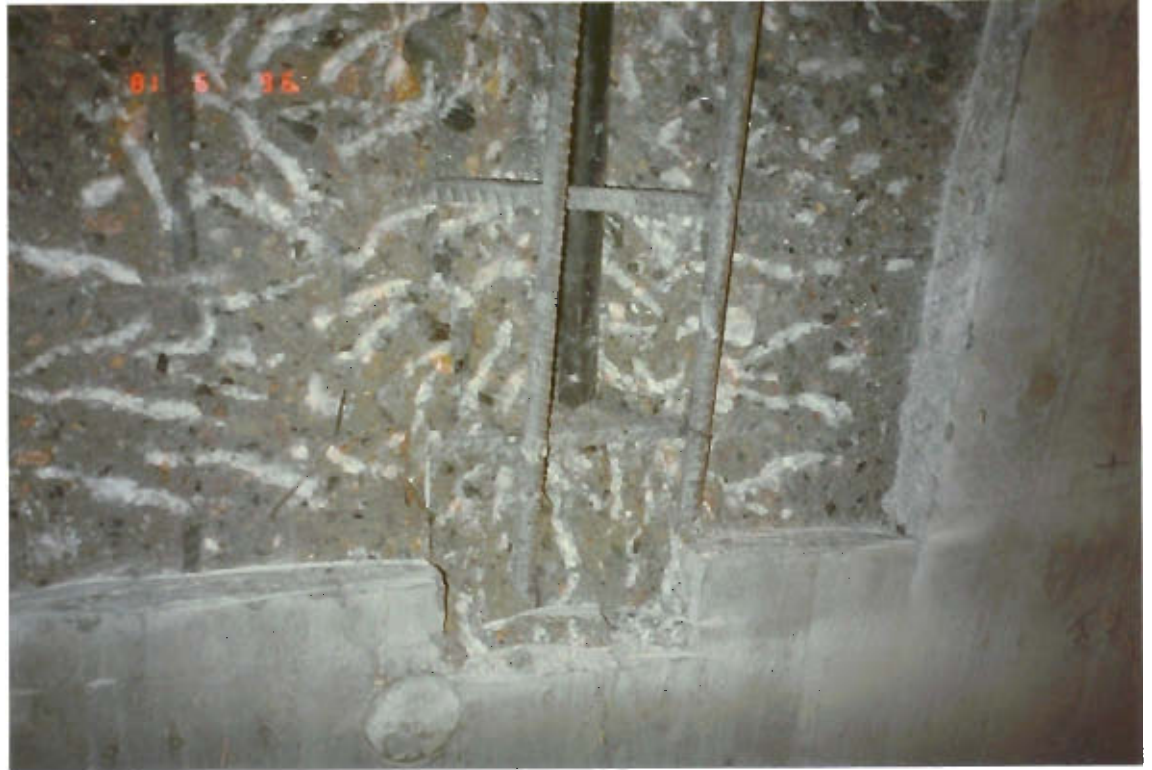
Figure 3.1: Removal of defect concrete. The concrete was damaged by frost expansion of the black cooling pipe behind the reinforcement. Damaged concrete was removed by cutting with pneumatic handheld hammers and the edges of the repair was cut with a diamond saw at an angle of 90° to the surface. Where reinforcement was exposed the concrete is removed min. 20 mm behind the bars, in order to admit materials to surround the reinforcement sufficiently.

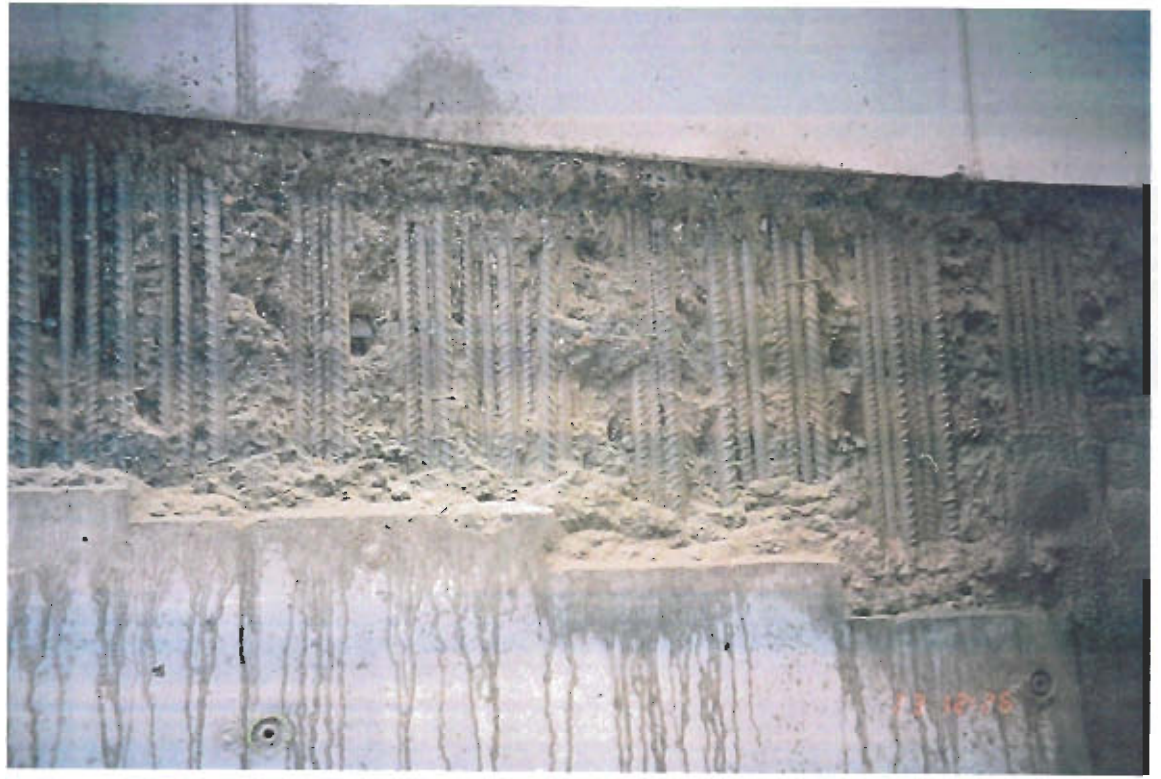
Figure 3.2: Removal of defect concrete. Damaged concrete was removed by cutting with pneumatic handheld hammers and the edges of the repair was cut with a diamond saw at an angel of 90° to the surface. The concrete behind the bars was not removed.
