HETEK

Repairs during the Construction Phase
Illustrations

Report No.99
1997

Road Directorate Denmark
Ministry of Transport

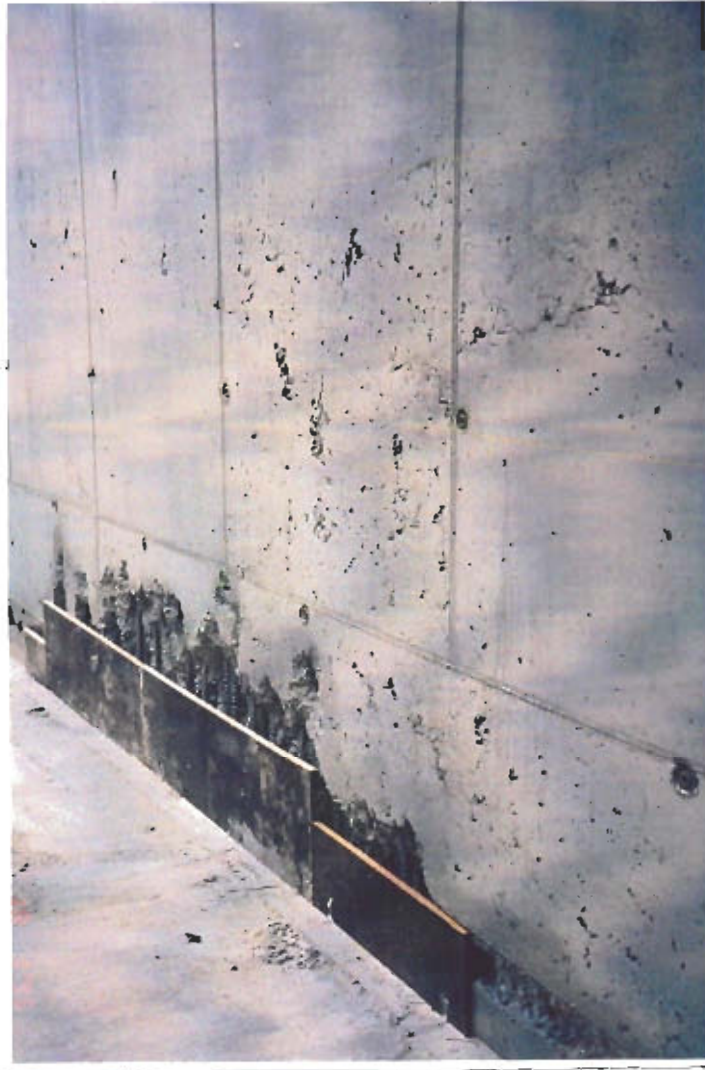
Figure 3.3: Filling out the hole in the lowest part of a wall in a tunnel with repair concrete. The hole in the wall was caused by lack of removal of ice before casting. The formwork for the repair concrete should be higher than the repair. The defect concrete above the repair should be removed before starting the repair process.

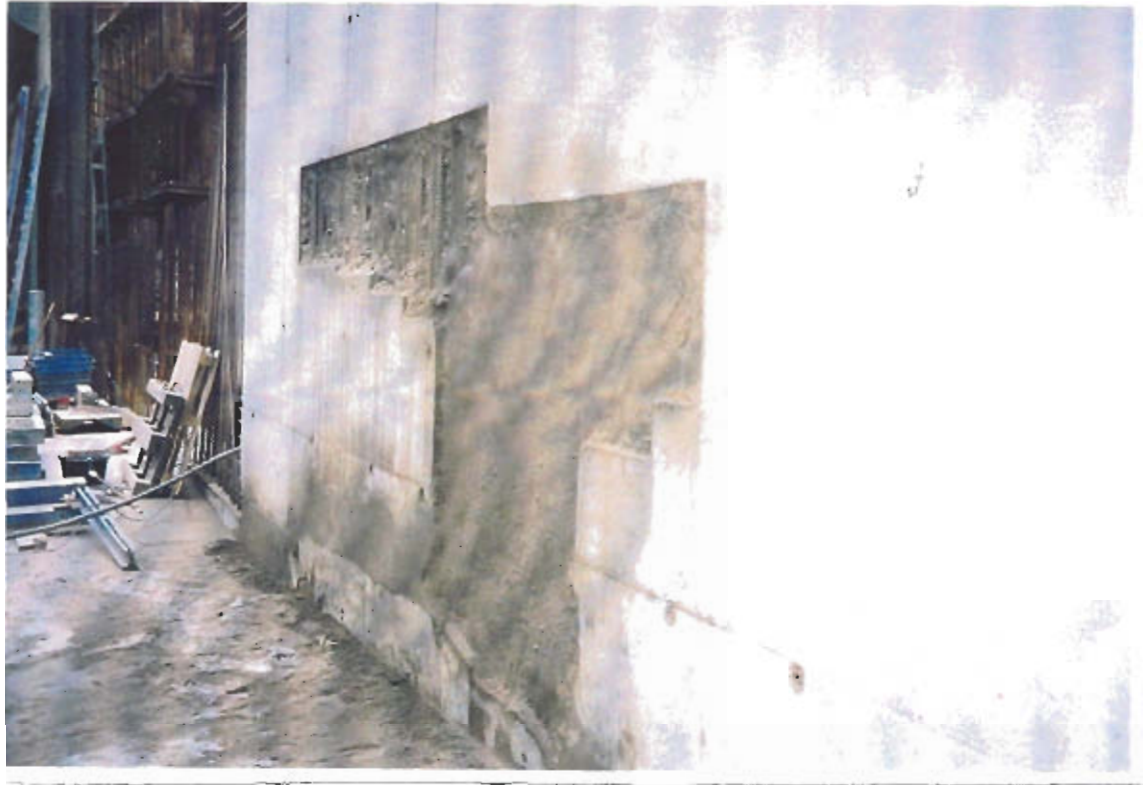
Figure 3.4: Repairs made with shotcrete after the first layer was applied. The area around the repair framed in order to avoid shootcrete on the surrounding surfaces.

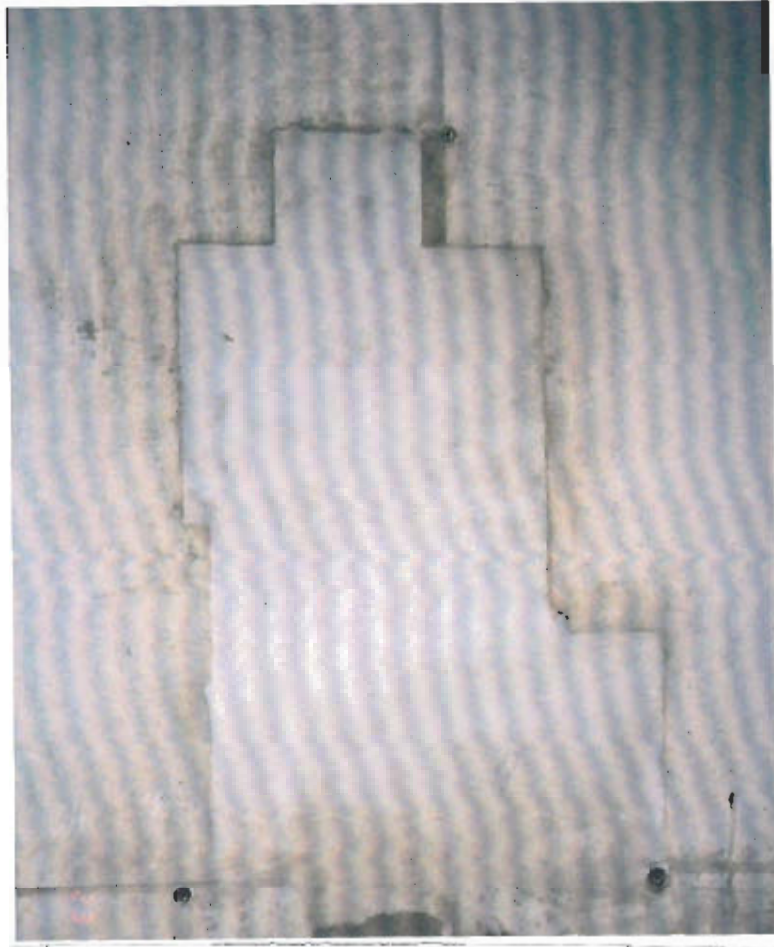
Figure 3.5: Finished repair with mortar. The surface of the repair is without defects. The repair has a surface texture which varies from the construction concrete.

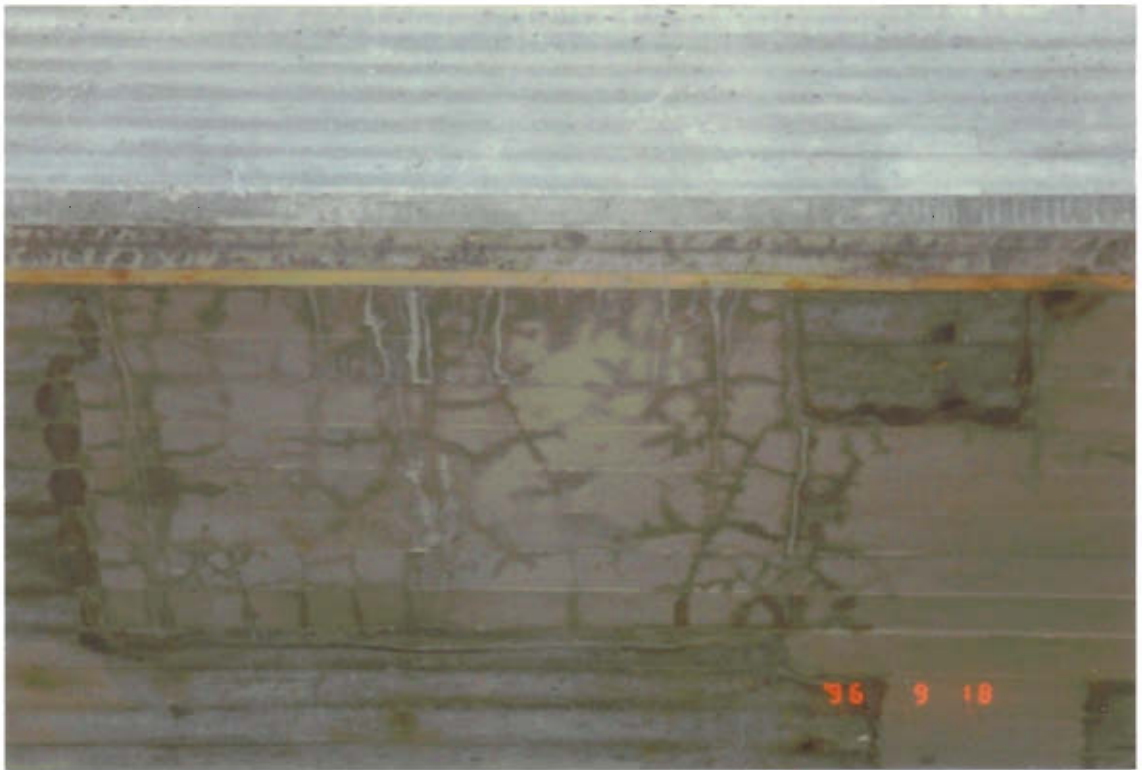
Figure 3.6: Repair with mortar. The surface cracked because of lack of protection against evaporation. The repair should be protected against evaporation for instance by attaching plastic.

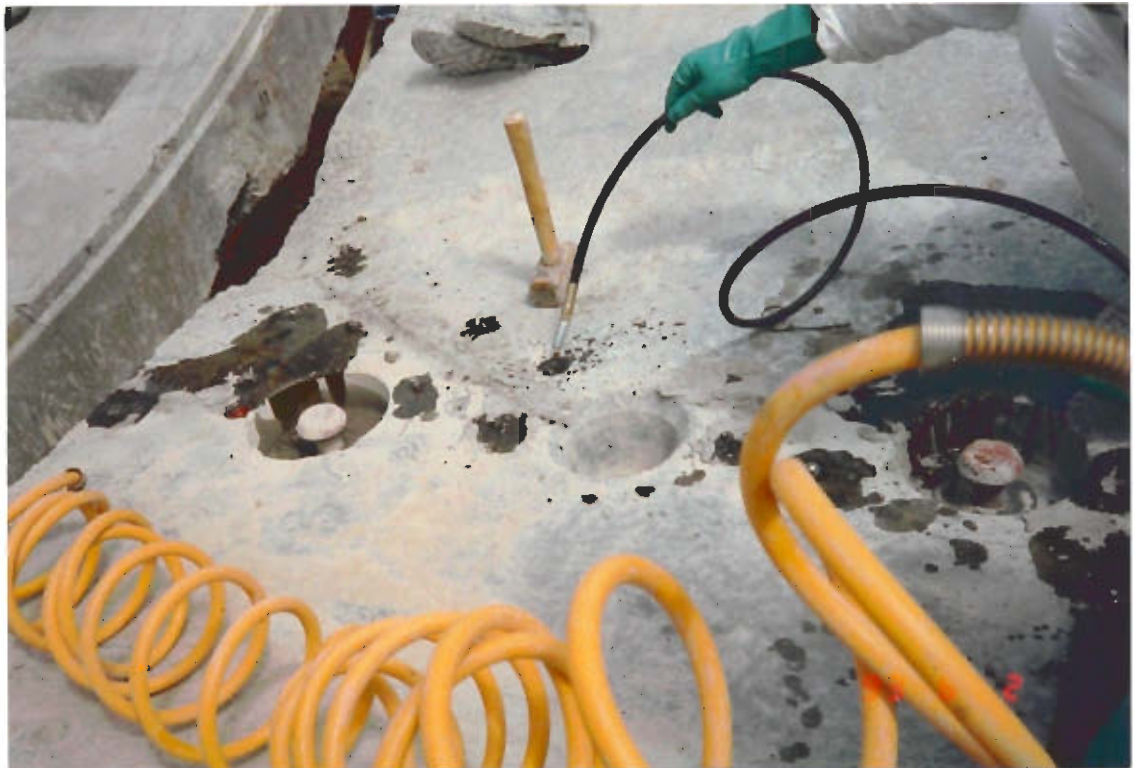
Figure 3.7: Injection of cracks in a tunnel lining element with epoxy through drilled-in packers. The injection should reestablish the structural integrity and fill out the cracks in order to make the element watertight. The packers are drilled from both sides of the crack at an angle of 45-60°

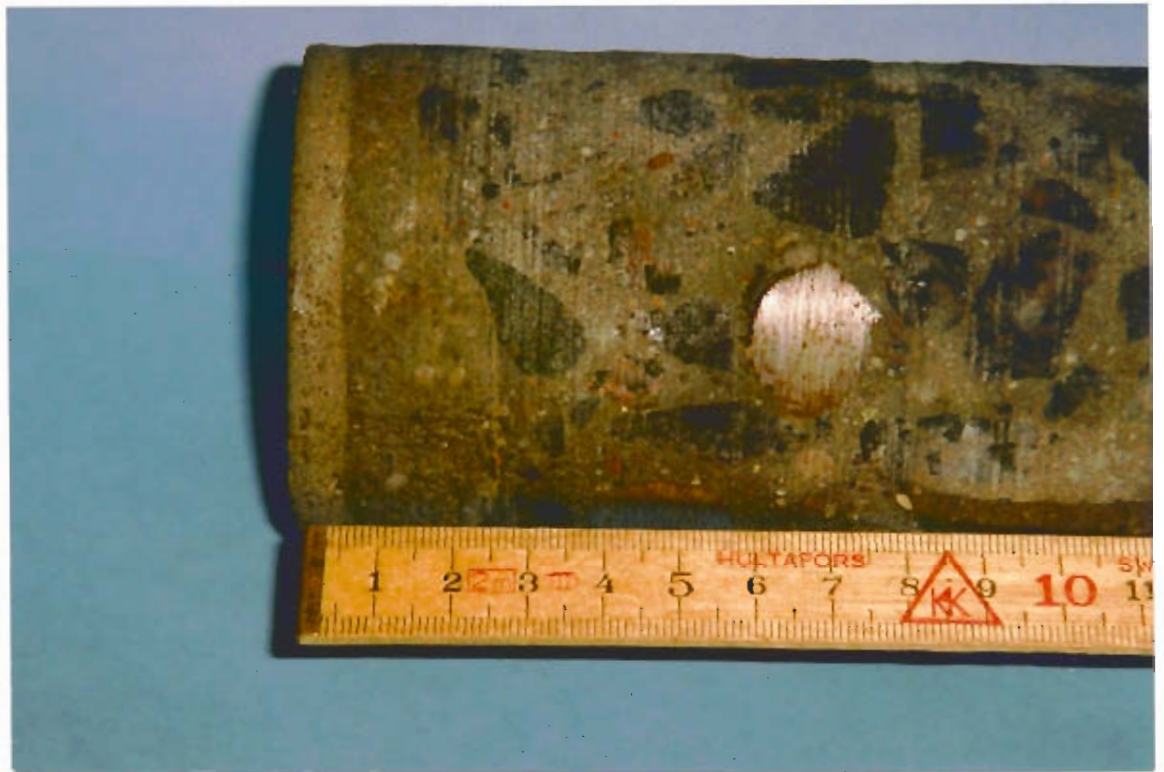
Figure 3.8: Core drilled out of a repair with mortar and shotcrete. The mortar has been applied as a finishing layer on top of the shotcrete. The casting joints between the different materials are filled out fully and the materials are well compacted and homogeneous.

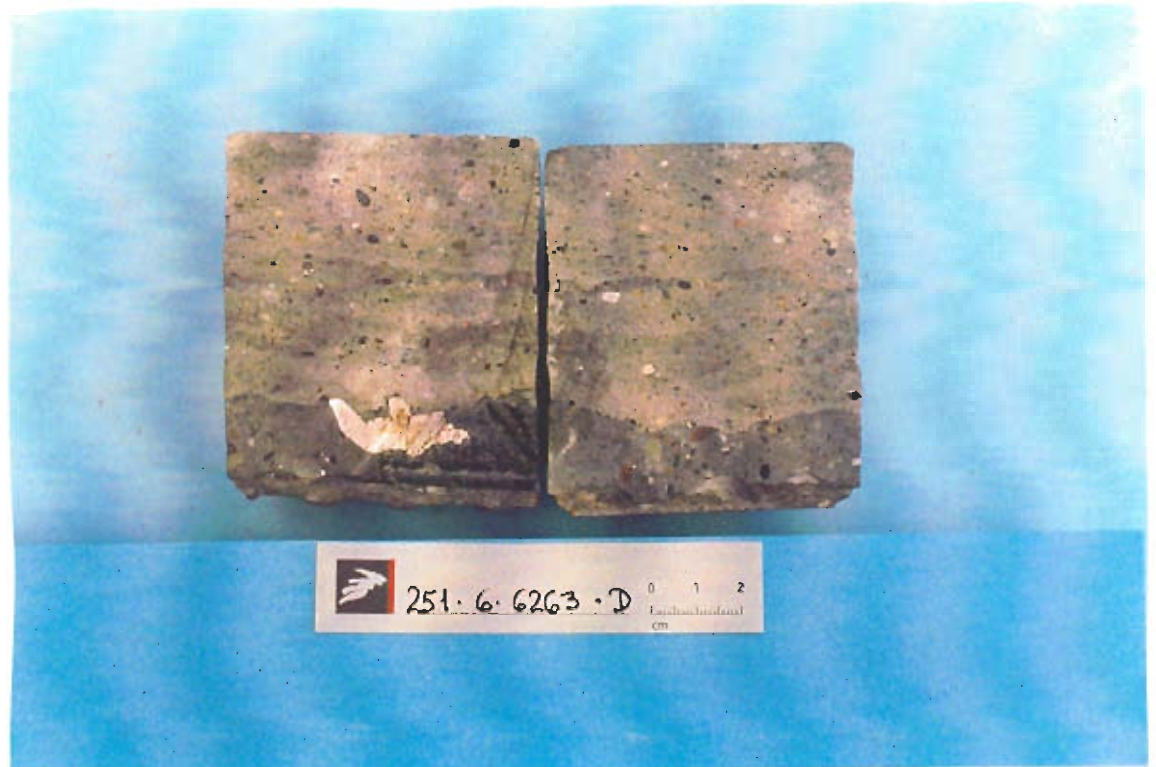
Figure 3.9 Core taken from a repaired tunnel wall made with shotcrete. The layer of the spraying is visible. The repaired is homogeneous without defects and there is full adhesion in the casting joint.

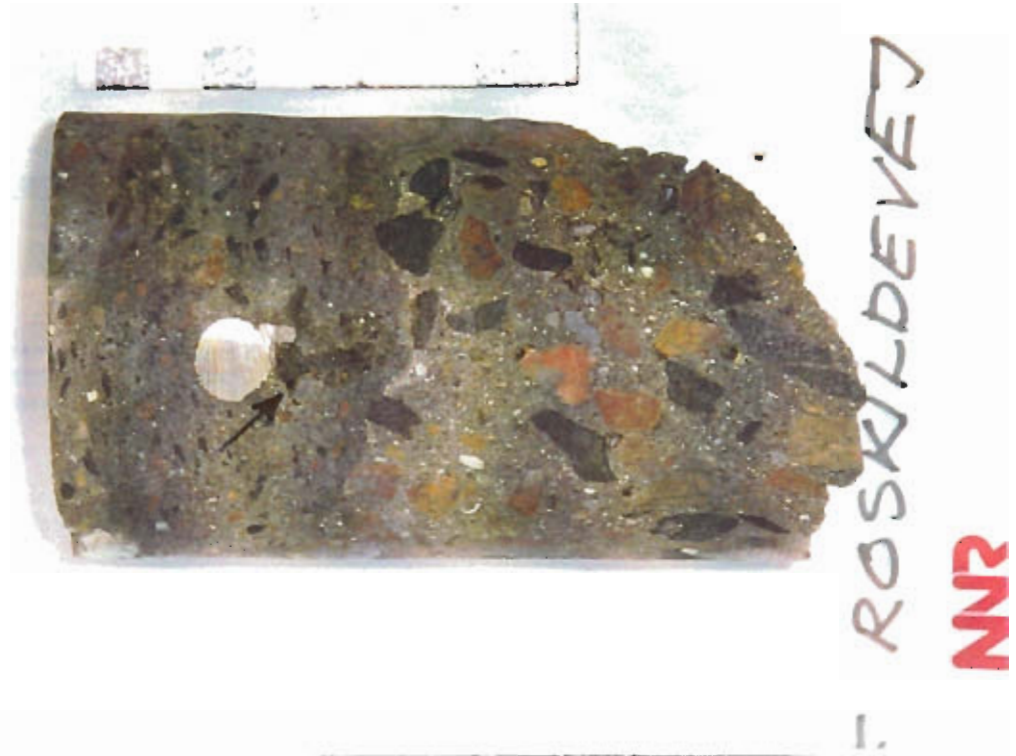
Figure 3.10 Core taken from a shotcrete repair of a sidebeam at a bridge. The arrow behind the reinforcement bar indicates air void and bad compaction due to poor workmanship. This will reduce the durability of corrosion protection of the reinforcement bar.

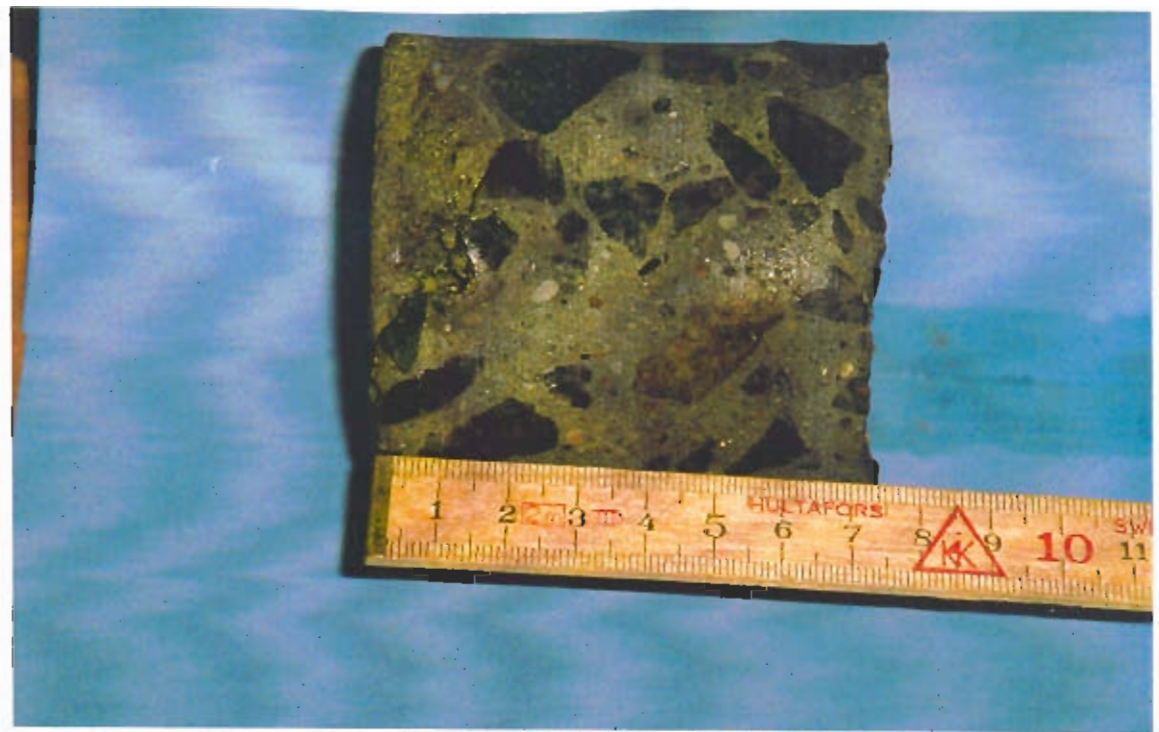
Figure 3.11 Core taken from repairs made with mortar. The core was located at the casting joint in the surface. There is a large air void in the casting joint, thus it was not visible before drilling the core.

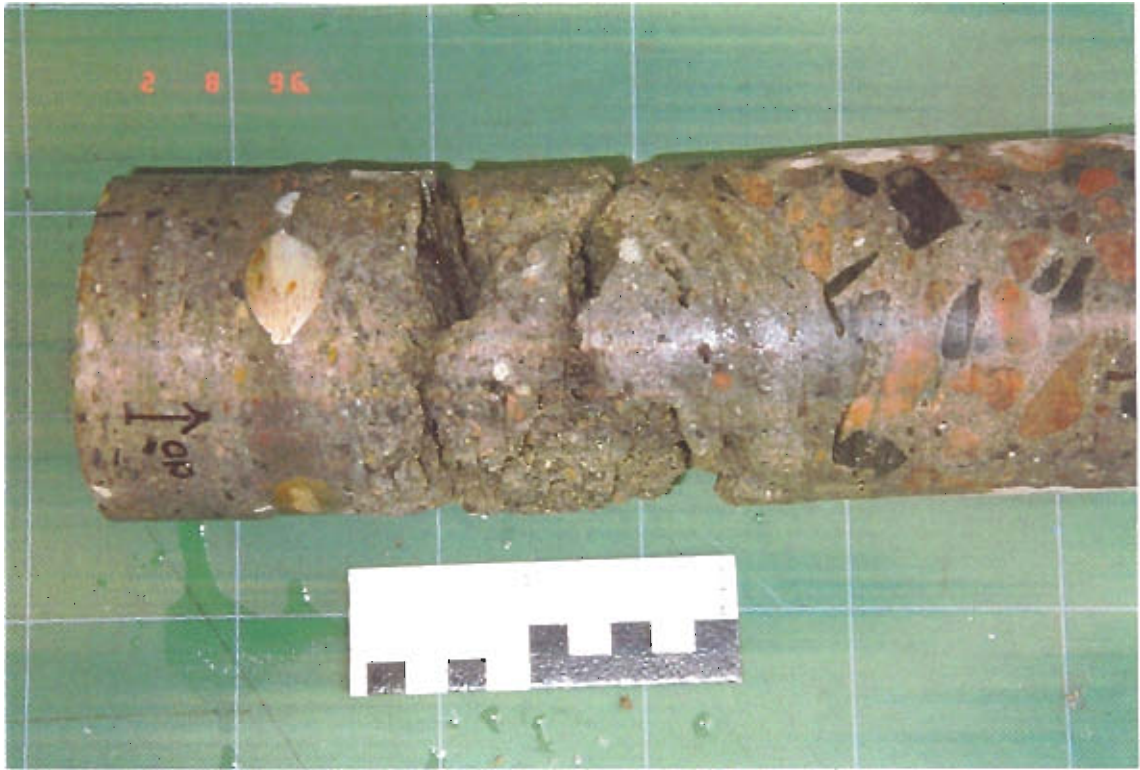
Figure 3.12 Core taken from repairs made with shotcrete. The shotcrete is poorly compacted and there are large air voids in the repair materials. This reduces the durability of the structure.

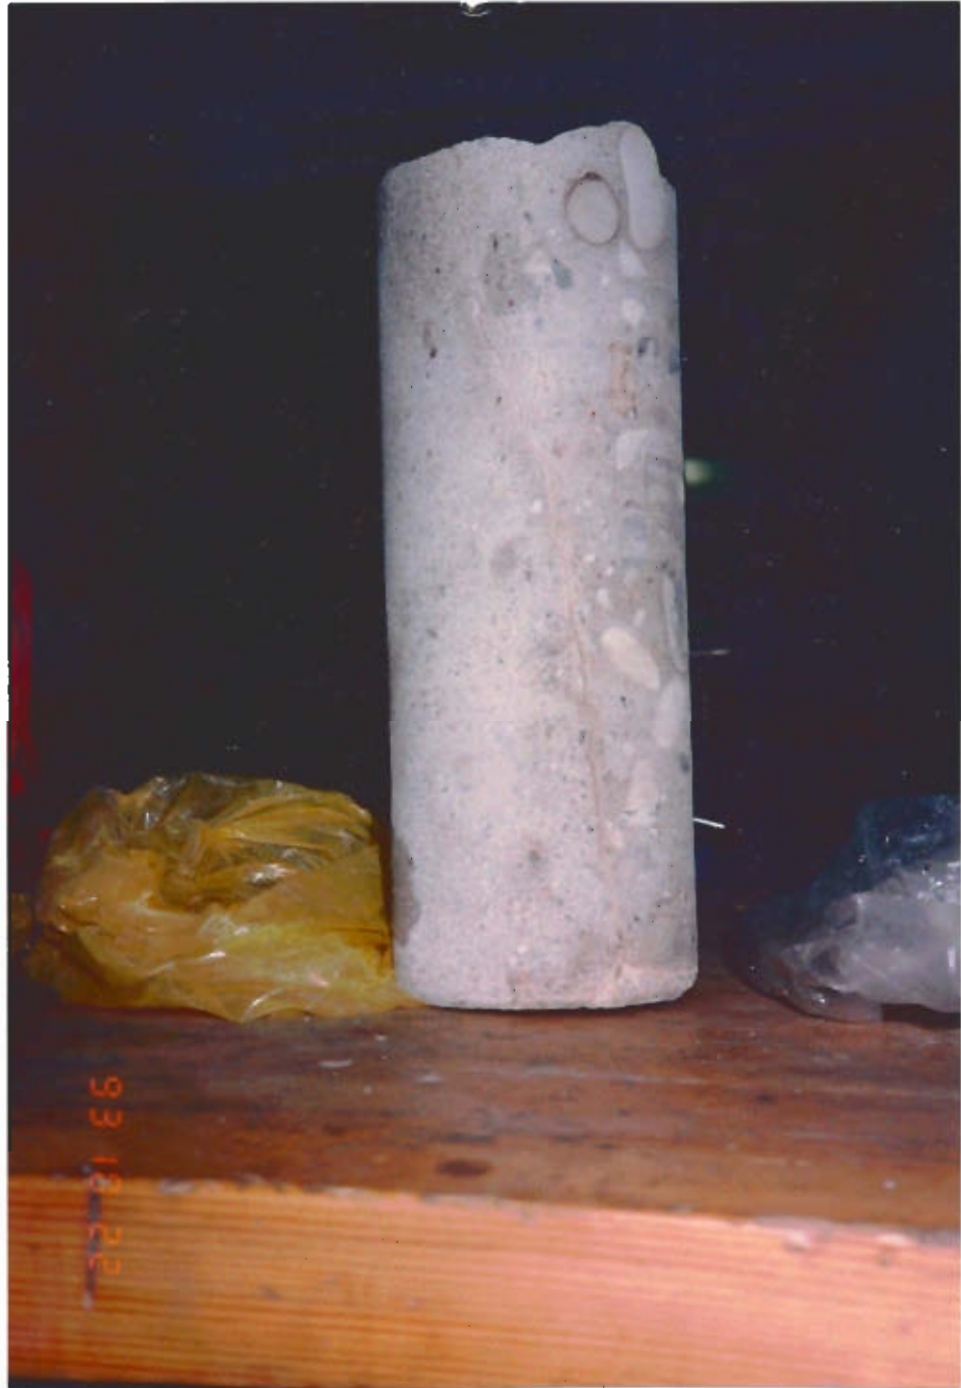
Figure 3.13 Core from injected crack. The crack was injected with polyurethane.

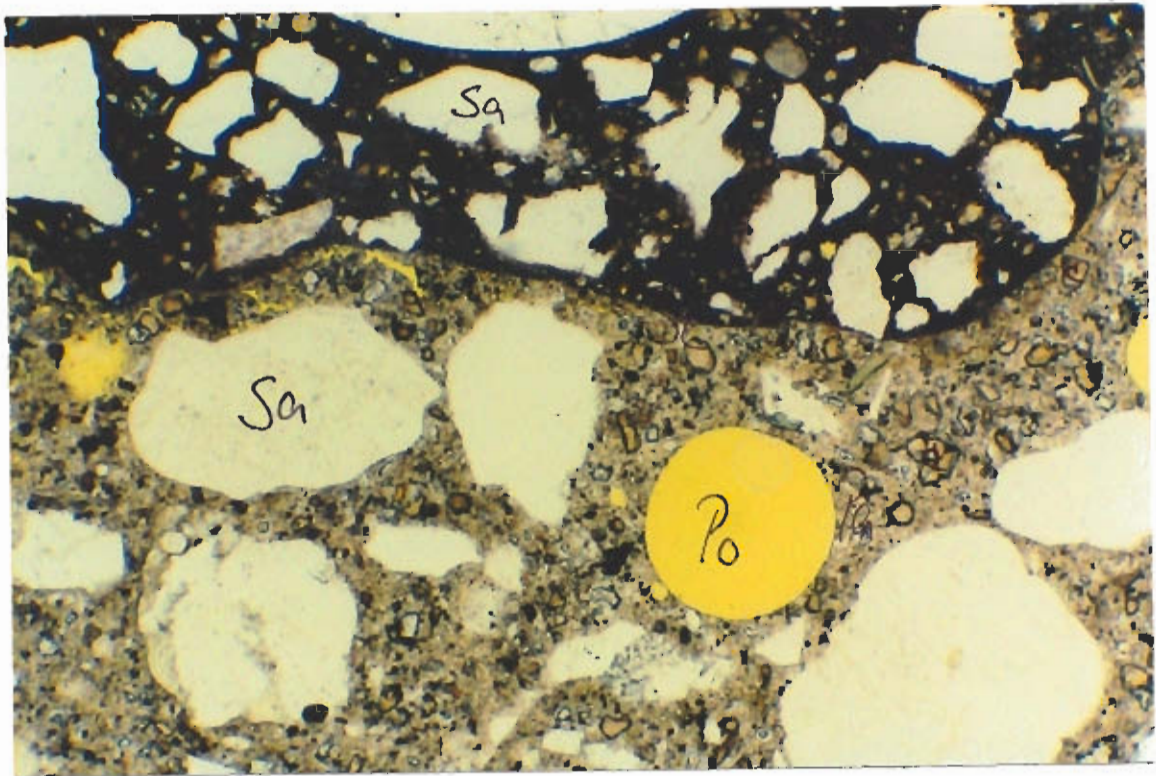
Figure 3.14 The illustration covers a thin section of app. 3x4 mm of a concrete core sample. In the middle the casting joint between mortar at the top and construction concrete at the bottom. The mortar is of good quality without inhomogenities and with full adhesion and no cracks in the joint.

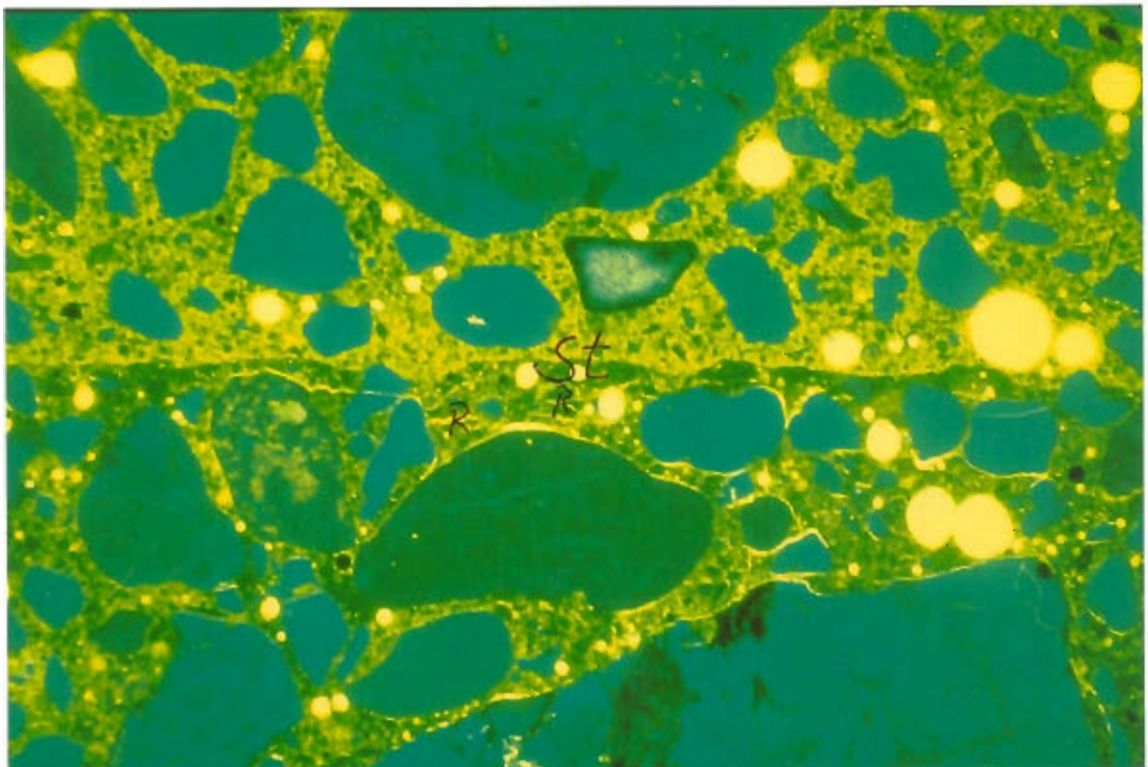
Figure 3.15 The illustration covers a thin section of app. 3 x 4 mm of a concrete core sample. In the middle of the picture is a joint between shotcrete repair materials. There is dust and dirt in the joint and the surface of the construction concrete was damaged due to the cutting with a pneumatic hammer.
