BioCrete TASK 7

Bioash in existing concrete structures

Taastrup, 30 May 2007
Project no: 1309129-07

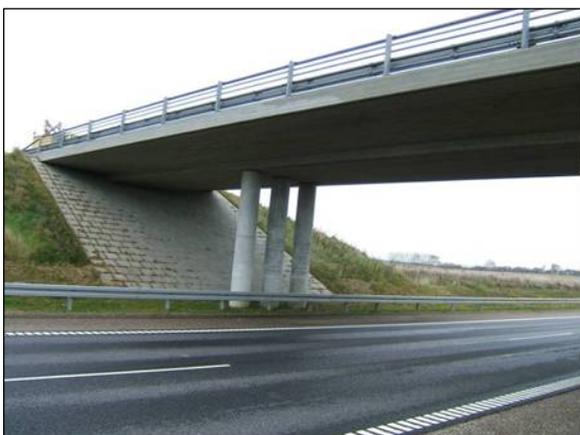
Figure 1. Image showing part of the west side of the bridge. On the edge beam is seen a colour difference between two types of concrete. The three columns are cast with different concrete types.

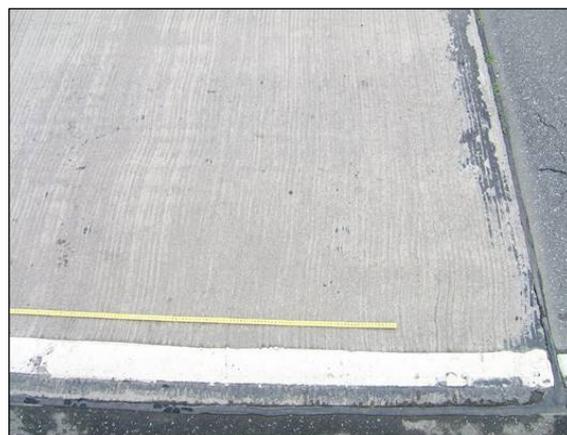
Figure 2. Surface of the settling slab cast using bio ash concrete of the demo bridge. A grid of fine cracks were observed in the surface as well as a few small break-offs at the dilation joint.

In general the field inspection revealed no cracks or wear such as tracks from heavy traffic was observed on the bio ash concrete (Figure 2).

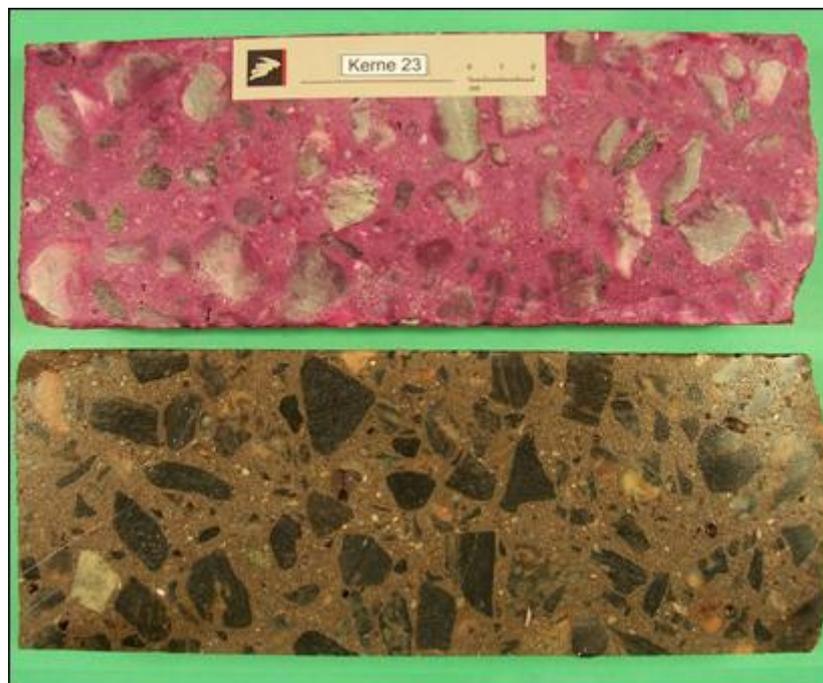
The petrographic analysis showed that the bioash concrete is in good condition in terms of durability and that no flaws from the casting and curing processes are observed (Figure 3).

Figure 3. Surface of the concrete to the left. In the top image pH-indicator is sprayed onto the concrete to reveal carbonation. – no carbonation found.

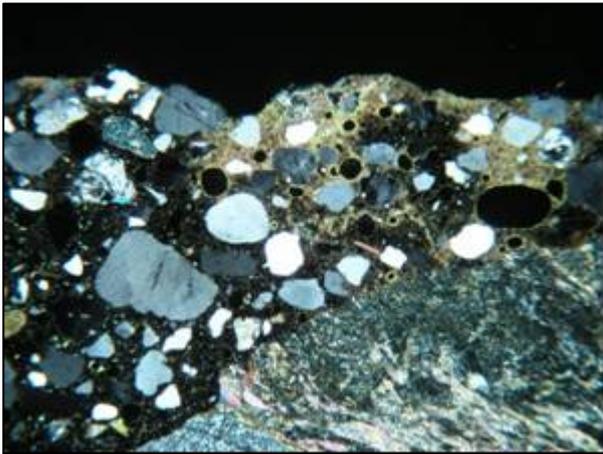
Figure 4. Image showing carbonated pasta (brownish) at the surface of the concrete. Cross-polarized light, field of view 3.8mm x 5.1mm.

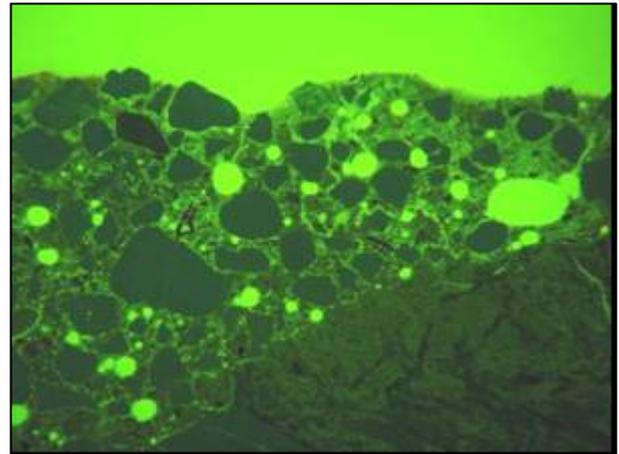
The microscopy analysis showed that there is no difference between the concrete at the surface and in the interior. A few fine cracks are observed at the surface extending to a maximum depth of 6mm (figure 5). In addition some cracks are observed in the paste and some adhesion cracks are found at the interface between paste and aggregate in the interior of the concrete. The observed surface cracks primarily extend through the paste and appear to have formed at a relatively early age. The surface is on the average carbonated to a depth of 3mm, however deeper carbonation is observed along cracks (figure 4). The air content of the concrete is estimated to be around 6 %-vol. The water to cement ratio is estimated to be about 0.40.

Figure 5. Image showing air void structure, micro cracks and difference in capillary porosity at the concrete surface. Fluorescent light mode, field of view 3.8mm x 5.1mm.

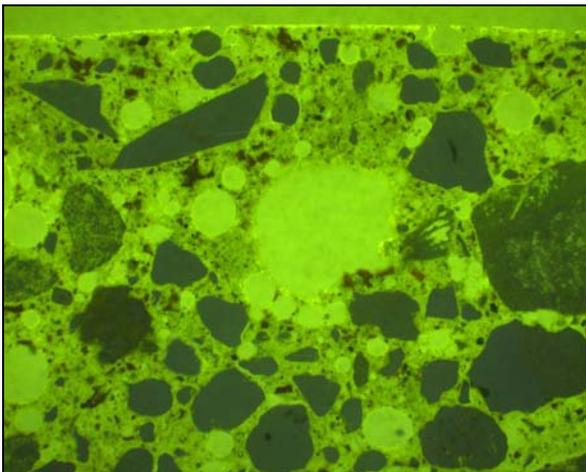
Figure 6. Image showing the surface of the bioash concrete. A fine crack is observed perpendicular to the surface towards the large air void. The very light green colour suggests that the concrete has a high w/c ratio. Fluorescent light mode, field of view 3.8mm x 5.1mm.

The bioash concrete of the water basin is generally in good condition and based on the microscopy analysis the compressive strength is estimated at around 20 MPa. The concrete has a high water to cement ratio, and areas of increased porosity due to short plastic cracks originating from the first few hours from placements are observed.

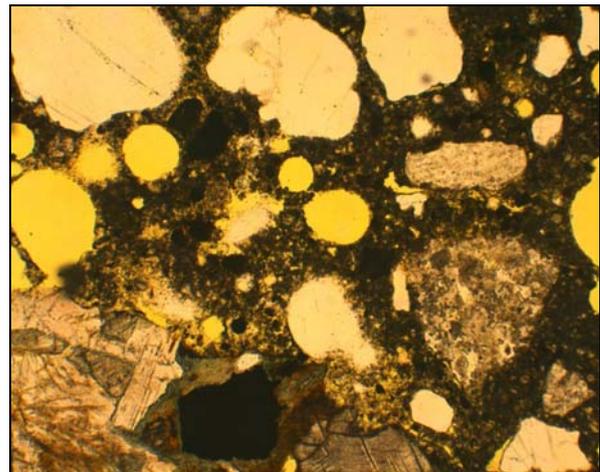
Figure 7. Image showing the interior of the concrete. An area of high porosity is seen along the paste aggregate interface. The concrete contains some rounded air voids. Polarized light mode, field of view 3.4mm x 4.3mm.

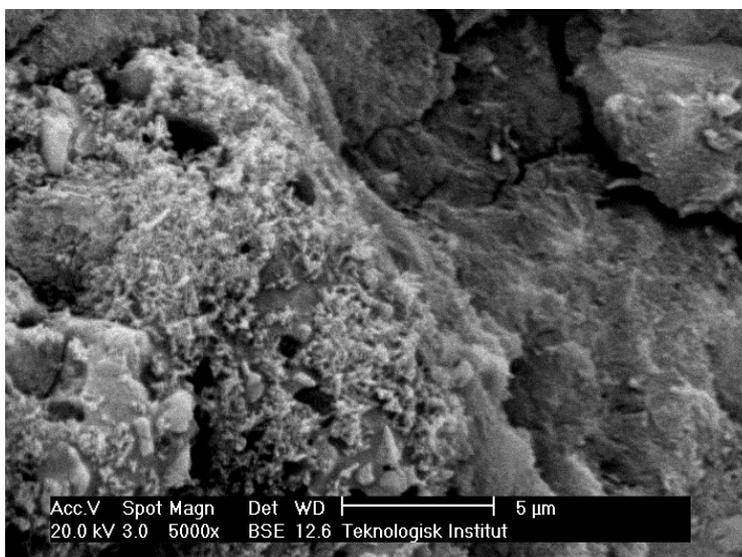
The individual bioash particles have well-defined edges even when the particles geometry is complex and the specific surface apparently high (Figure 8). This indicates that no hydration/reaction has taken place between the bioash and the other constituents of the cement paste.

Figure 8. The rough and irregular surface of a bioash particle.
